LIMITED LEAD-BASED PAINT/CERAMIC TILE INSPECTION REPORT

ENCINITA ELEMENTARY SCHOOL
NE CAMPUS, PLAYGROUNDS, PORTABLES 28 & 29 PROJECT
4515 ENCINITA AVENUE
ROSEMEAD, CALIFORNIA 91770

Project Number EE 23-Z0046-0029
March 14, 2023

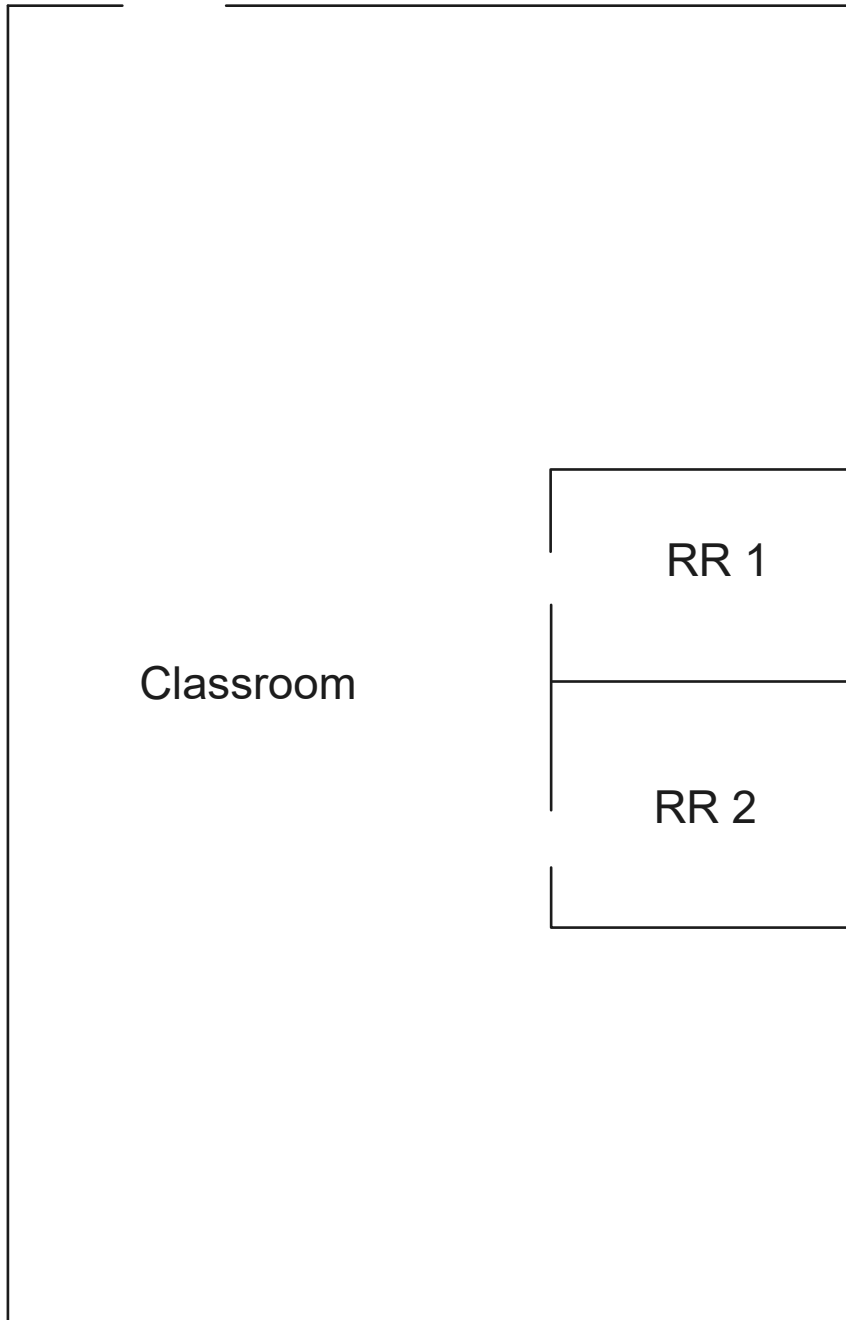
Portable 28

Info: No Lead-Based Paint Identified

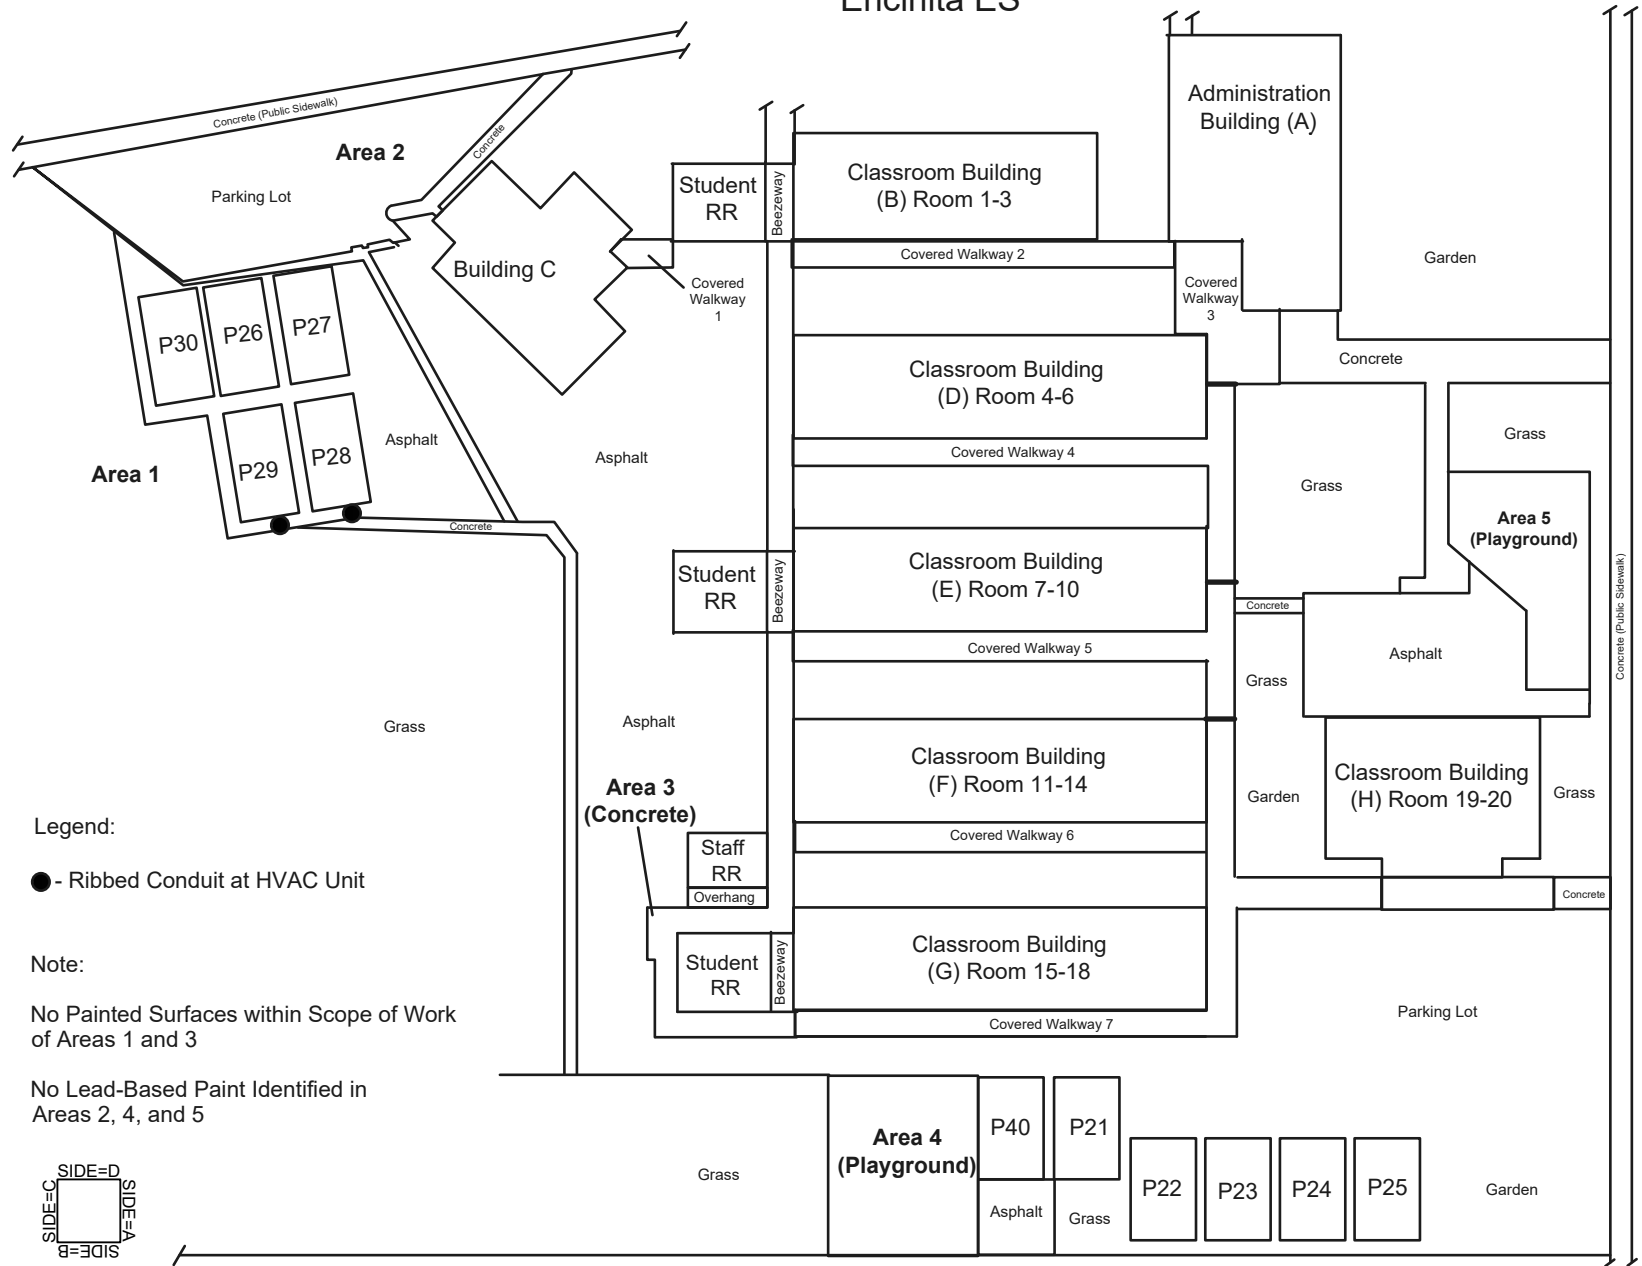
Encinita ES

● - Ribbed Conduit at HVAC Unit

No Painted Surfaces within Scope of Work of Areas 1 and 3

No Lead-Based Paint Identified in Areas 2, 4, and 5

Info: Lead-Based Paint Identified

It is recommended that all renovation, remodelling, construction, or demolition actions that might potentially disturb surfaces covered with lead-based paint be performed by properly trained and qualified personnel.
