## LIMITED LEAD-BASED PAINT INSPECTION REPORT

JANSON ELEMENTARY SCHOOL  
PLAYGROUNDS  
8628 MARSHALL AVENUE  
ROSEMEAD, CALIFORNIA 91770

Project Number EE 23-Z0046-0037  
March 13, 2023

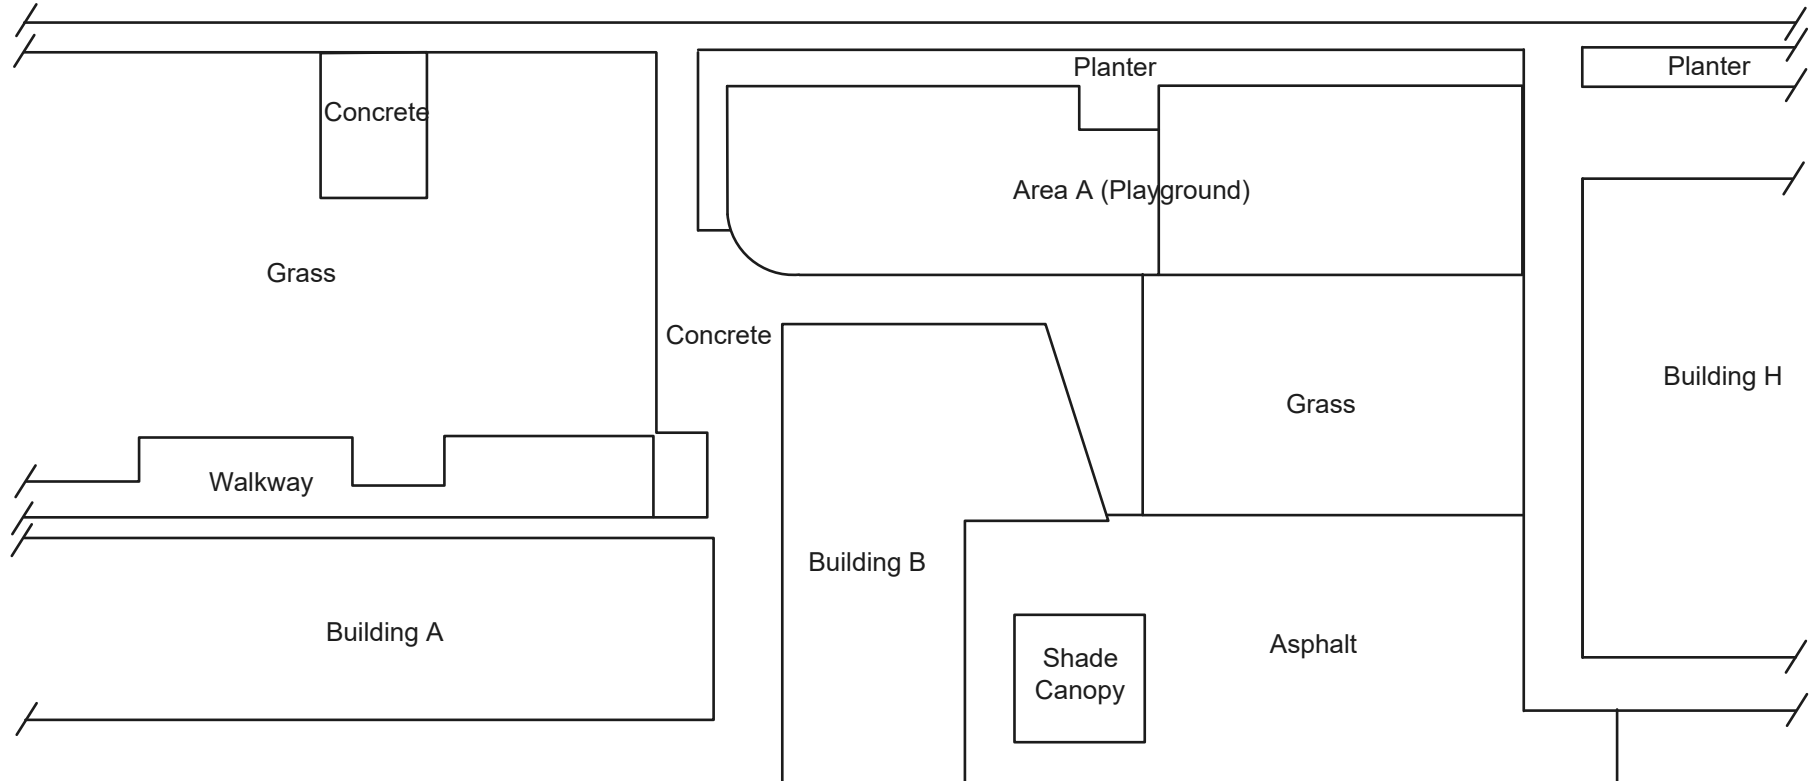
# Area A

**Info:** No Lead-Based Paint Identified

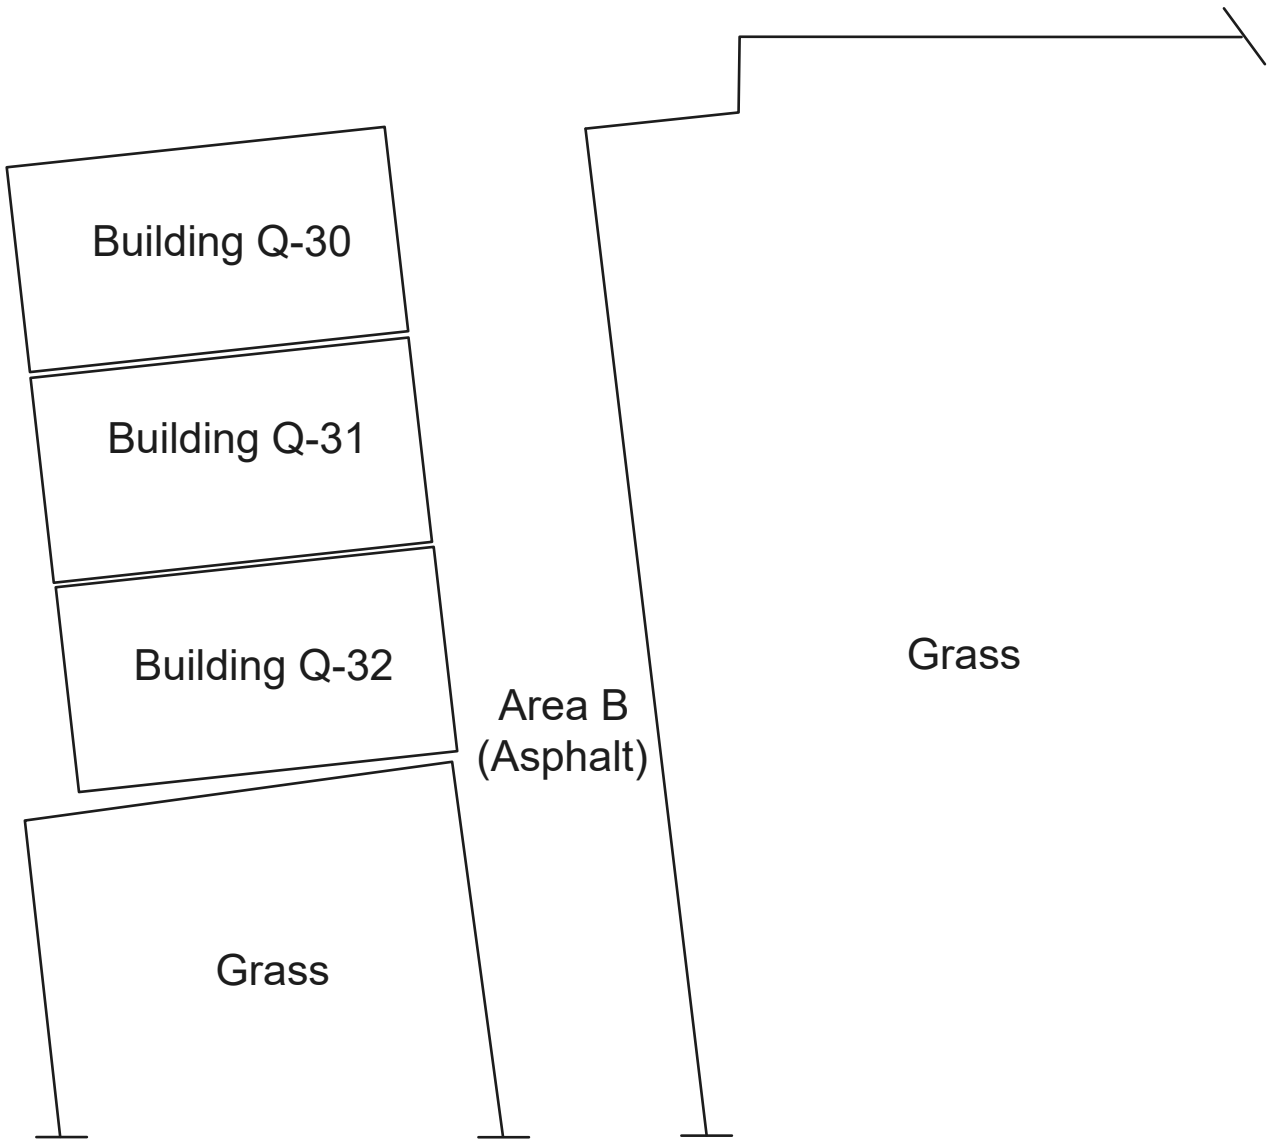
# Area B

<sup>1</sup> NOTE: 1) No paint on asphalt paving of Area B (paving by Portable 32).

**Client:** Rosemead SD      **Project#:** 23-Z0046-0037      **Info:** No Painted Surfaces / No LBP Testing

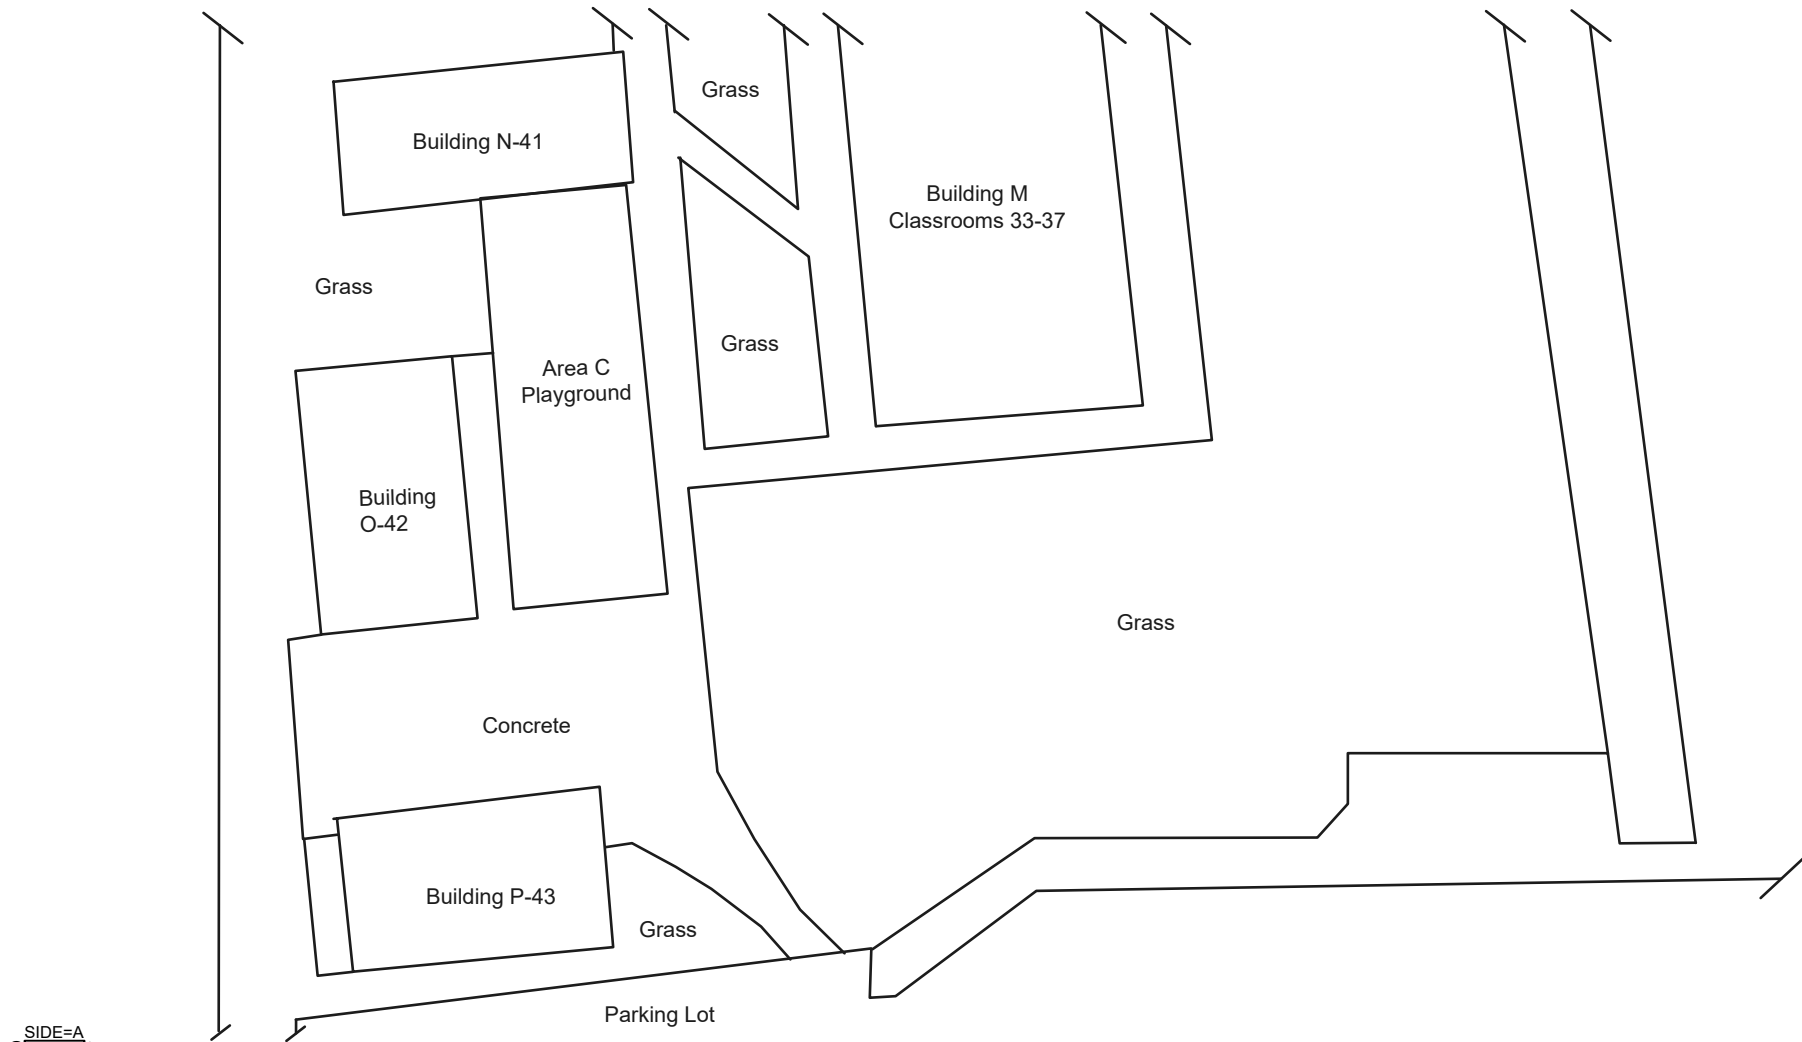
## Area C

**Info:** No Lead-Based Paint Identified
