## LIMITED ASBESTOS INSPECTION REPORT

ENCINITA ELEMENTARY SCHOOL  
PAINTING PROJECT  
4515 ENCINITA AVENUE  
ROSEMEAD, CALIFORNIA 91770

Project Number EE 20-Z0046-0027  
February 26, 2020

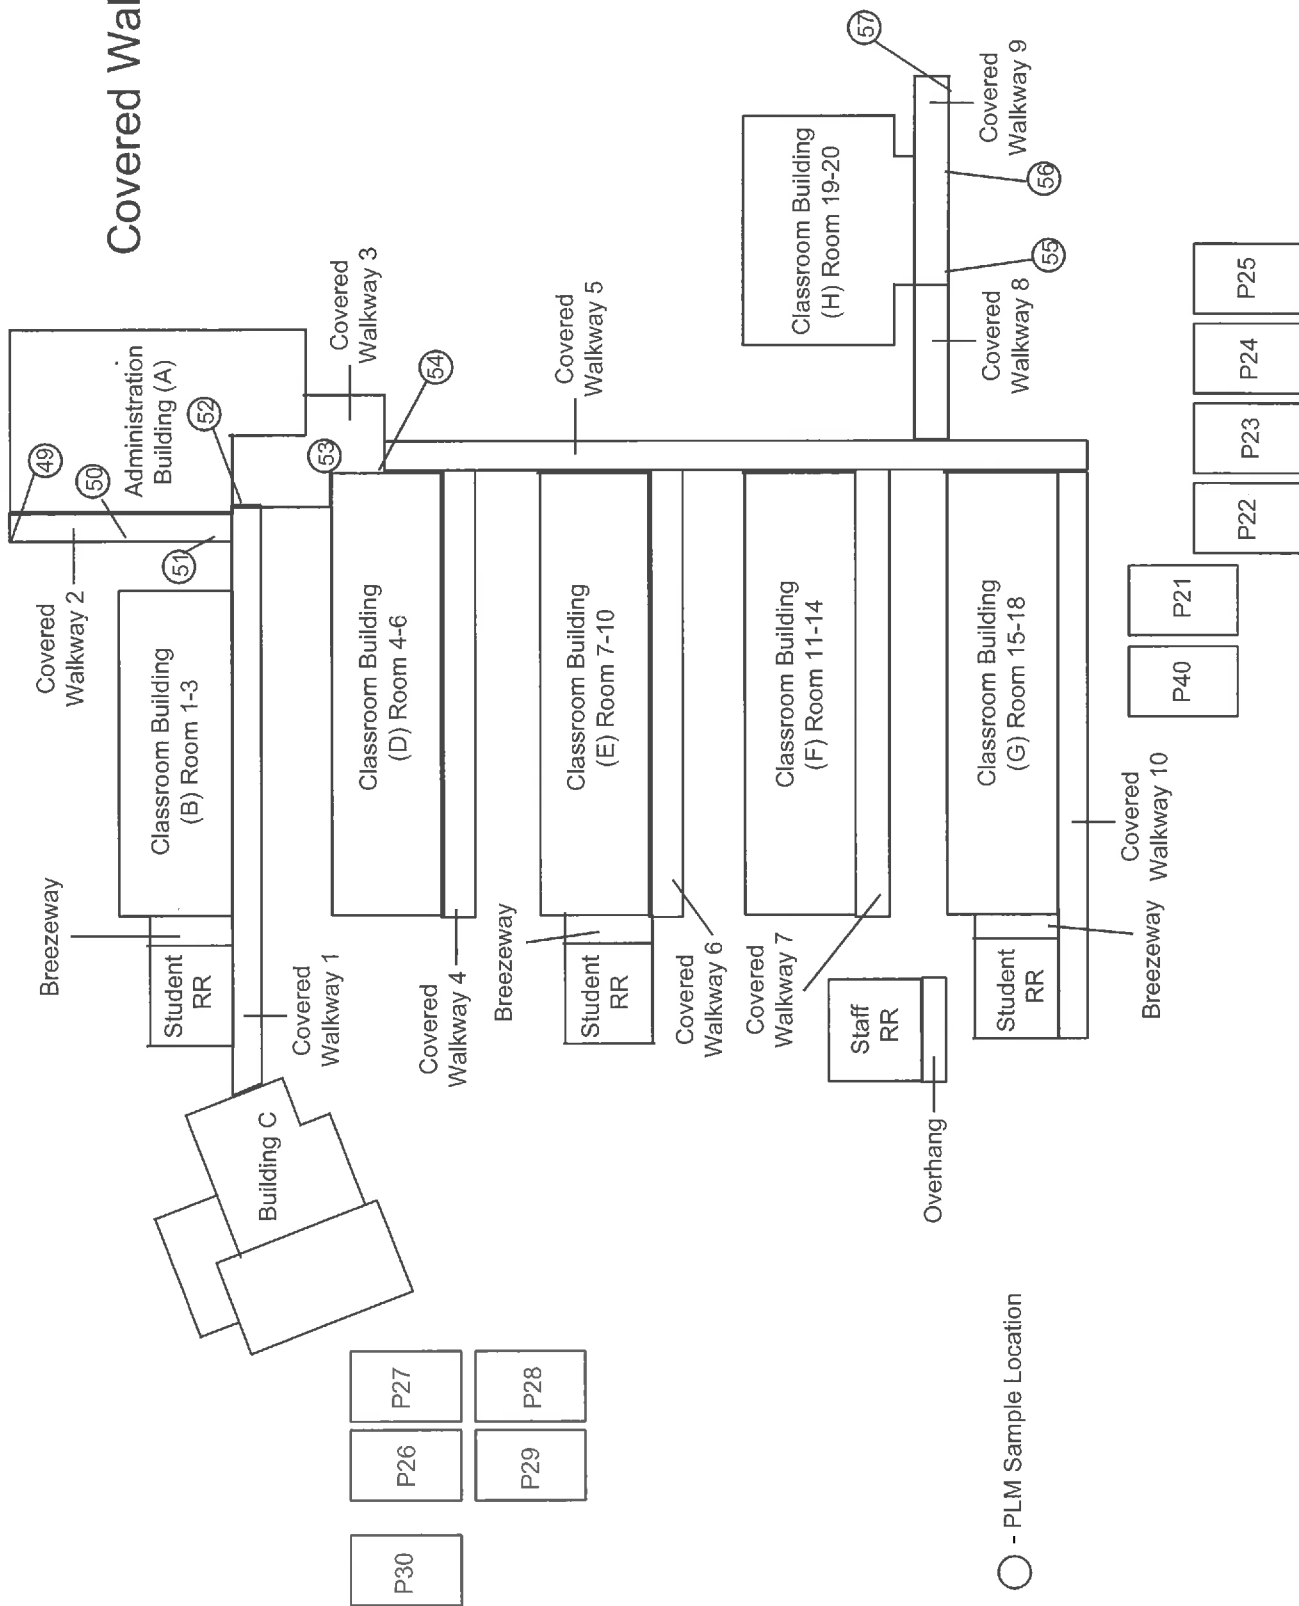
# Covered Walkway

| Homogeneous Material # | Material Description | Material Location | Estimated Quantity | Condition <sup>T</sup> | Type <sup>U</sup> | Friable | Percent Damaged | Sample Number | Sample Location | Analytical Results |
|---|---|---|---|---|---|---|---|---|---|---|
| 10 | Stucco | Covered walkway no. 2 ceilings | 450 Square Feet | G | Surf. | No | 0 | 2002070027RK-49 | Northwest | NAD |
| 10 | Stucco | Covered walkway no. 3 ceilings | 900 Square Feet | G | Surf. | No | 0 | 2002070027RK-52 | Northwest | NAD |
| 11 | Stucco | Covered walkway no. 9 ceilings | 470 Square Feet | G | Surf. | No | 0 | 2002070027RK-55 | Southwest | NAD |

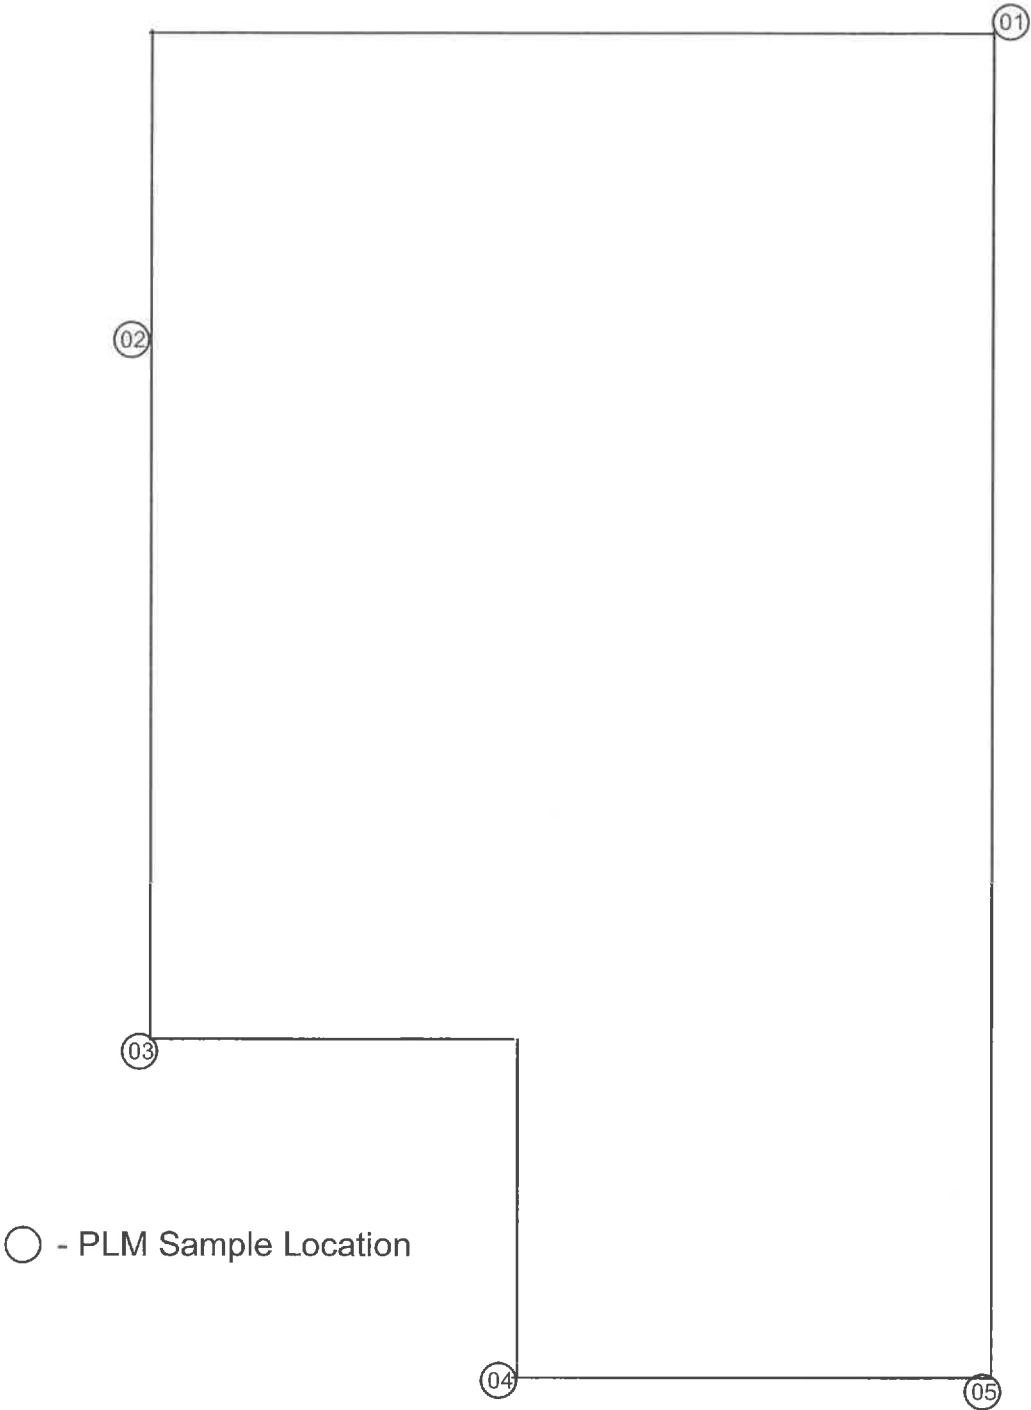
Administration  
Building (A)

| Homogeneous Material # | Material Description | Material Location | Estimated Quantity | Condition <sup>A</sup> | Type <sup>B</sup> | Friable | Percent Damaged | Sample Number | Sample Location | Analytical Results |
|---|---|---|---|---|---|---|---|---|---|---|
| 1 | Stucco | Throughout exterior walls | 2,500 Square Feet | G | Surf. | No | 0 | 2002060027RK-01 | North wall, east end | NAD <sup>D</sup> |

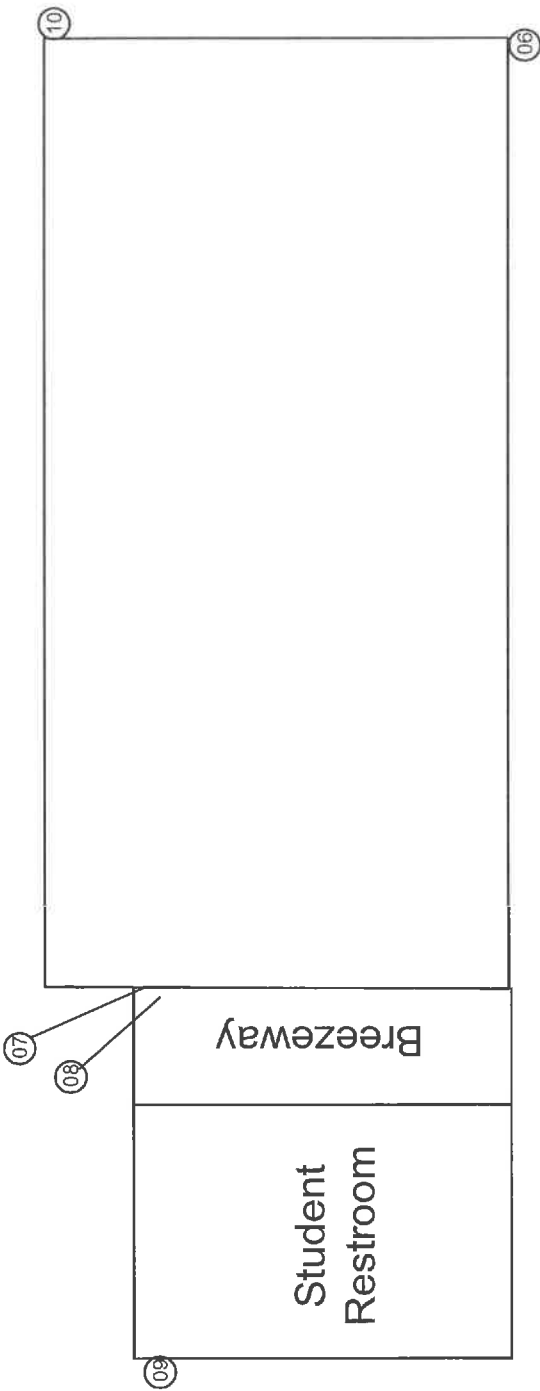
# Classroom Building (B) Room 1-3

| Homogeneous Material # | Material Description | Material Location | Estimated Quantity | Condition <sup>A</sup> | Type <sup>B</sup> | Friable | Percent Damaged | Sample Number | Sample Location | Analytical Results |
|---|---|---|---|---|---|---|---|---|---|---|
| 2 | Stucco | Throughout exterior walls and breezeway ceiling | 2,500 Square Feet | G | Surf. | No | 0 | 2002060027RK-06 | South wall, east end | NAD |

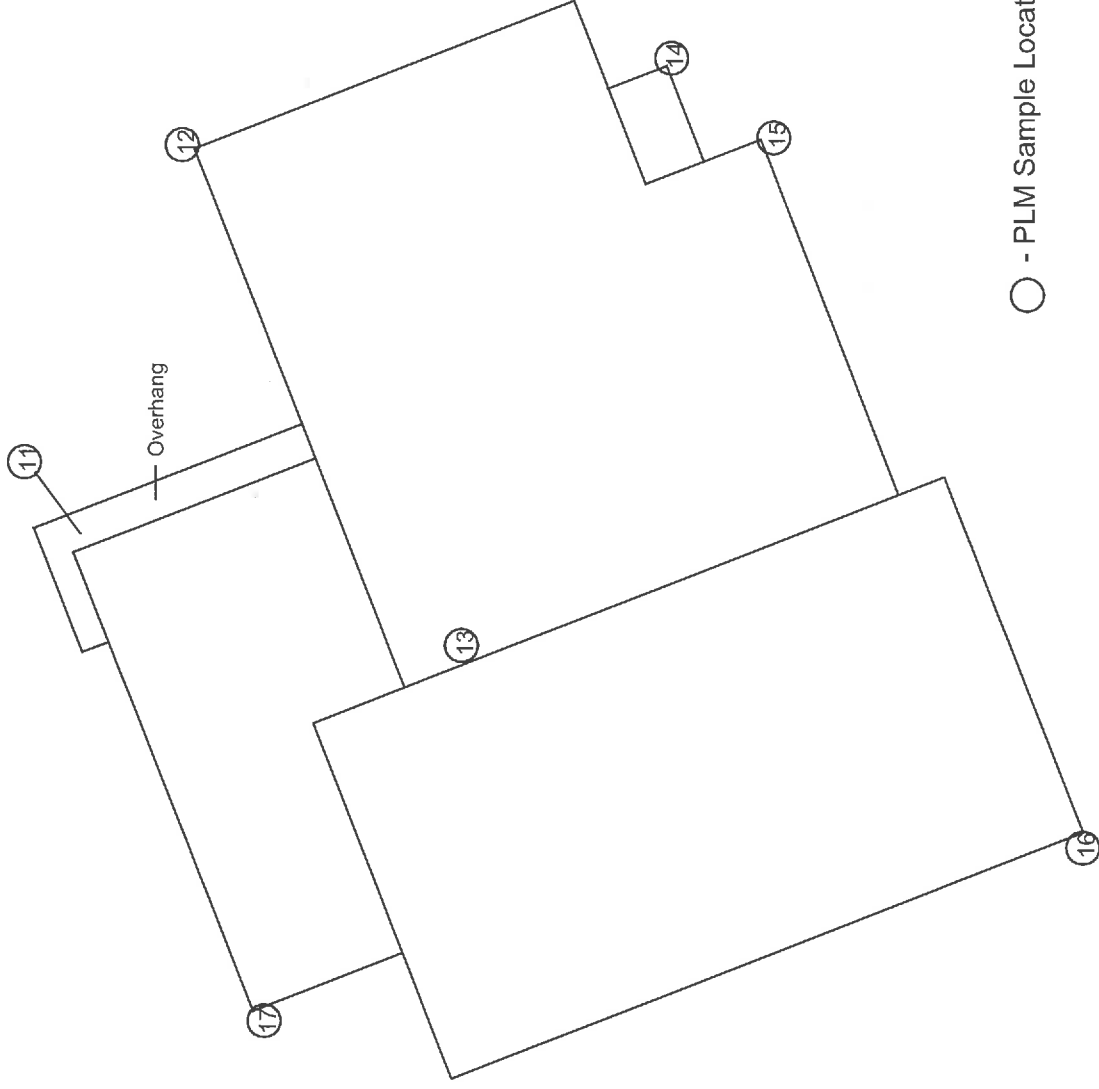
# Building C (Multi-Purpose Building)

| Homogeneous Material # | Material Description | Material Location | Estimated Quantity | Condition <sup>F</sup> | Type <sup>G</sup> | Friable | Percent Damaged | Sample Number | Sample Location | Analytical Results |
|---|---|---|---|---|---|---|---|---|---|---|
| 3 | Stucco | Throughout exterior walls and overhangs | 5,000 Square Feet | G | Surf. | No | 0 | 2002060027RK-11 | Northeast overhang ceiling | NAD <sup>I</sup> |

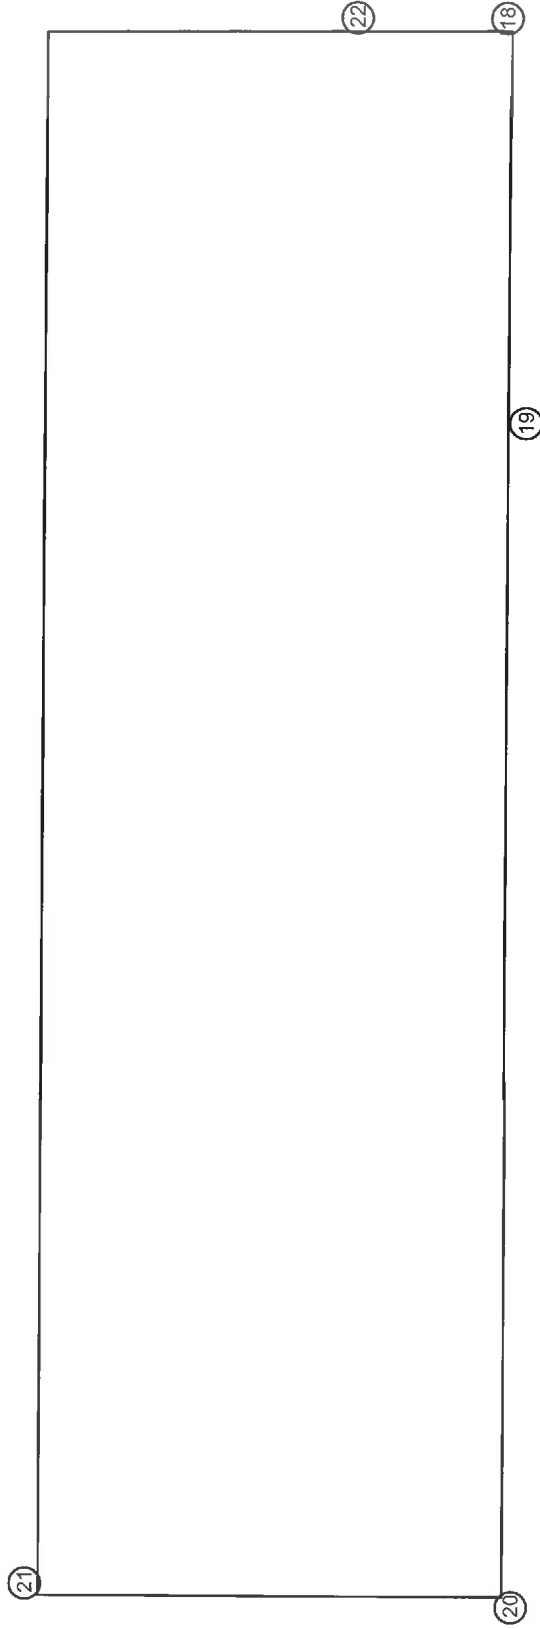
# Classroom Building (D) Room 4-6

| Homogeneous Material # | Material Description | Material Location | Estimated Quantity | Condition <sup>F</sup> | Type <sup>G</sup> | Friable | Percent Damaged | Sample Number | Sample Location | Analytical Results |
|---|---|---|---|---|---|---|---|---|---|---|
| 4 | Stucco | Throughout exterior walls | 2,000 Square Feet | G | Surf. | No | 0 | 2002060027RK-18 | East wall, south end | NAD |

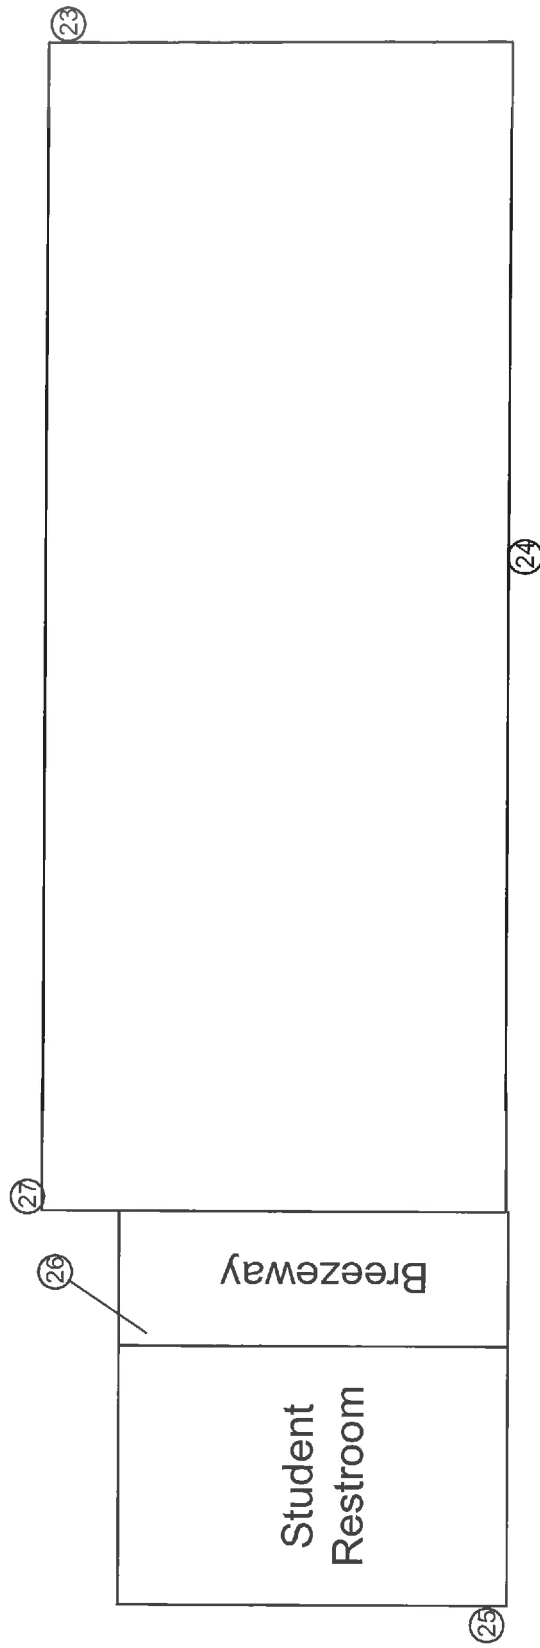
# Classroom Building (E) Room 7-10

| Homogeneous Material # | Material Description | Material Location | Estimated Quantity | Condition <sup>K</sup> | Type <sup>L</sup> | Friable | Percent Damaged | Sample Number | Sample Location | Analytical Results |
|---|---|---|---|---|---|---|---|---|---|---|
| 5 | Stucco | Throughout exterior walls and Breezeway ceilings | 2,500 Square Feet | G | Surf. | No | 0 | 2002060027RK-23 | East wall, north end | NAD <sup>N</sup> |

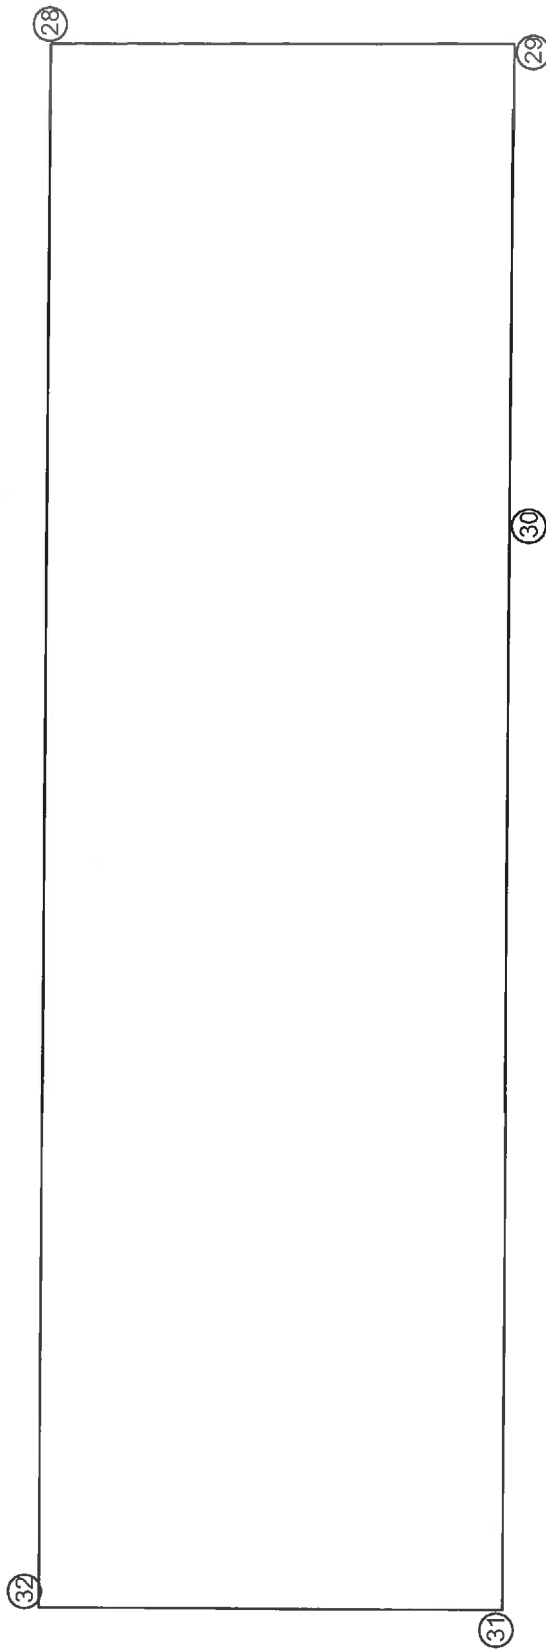
# Classroom Building (F) Room 11-14

| Homogeneous Material # | Material Description | Material Location | Estimated Quantity | Condition <sup>K</sup> | Type <sup>L</sup> | Friable | Percent Damaged | Sample Number | Sample Location | Analytical Results |
|---|---|---|---|---|---|---|---|---|---|---|
| 6 | Stucco | Throughout exterior walls | 2,000 Square Feet | G | Surf. | No | 0 | 2002070027RK-28 | East wall, north end | NAD |

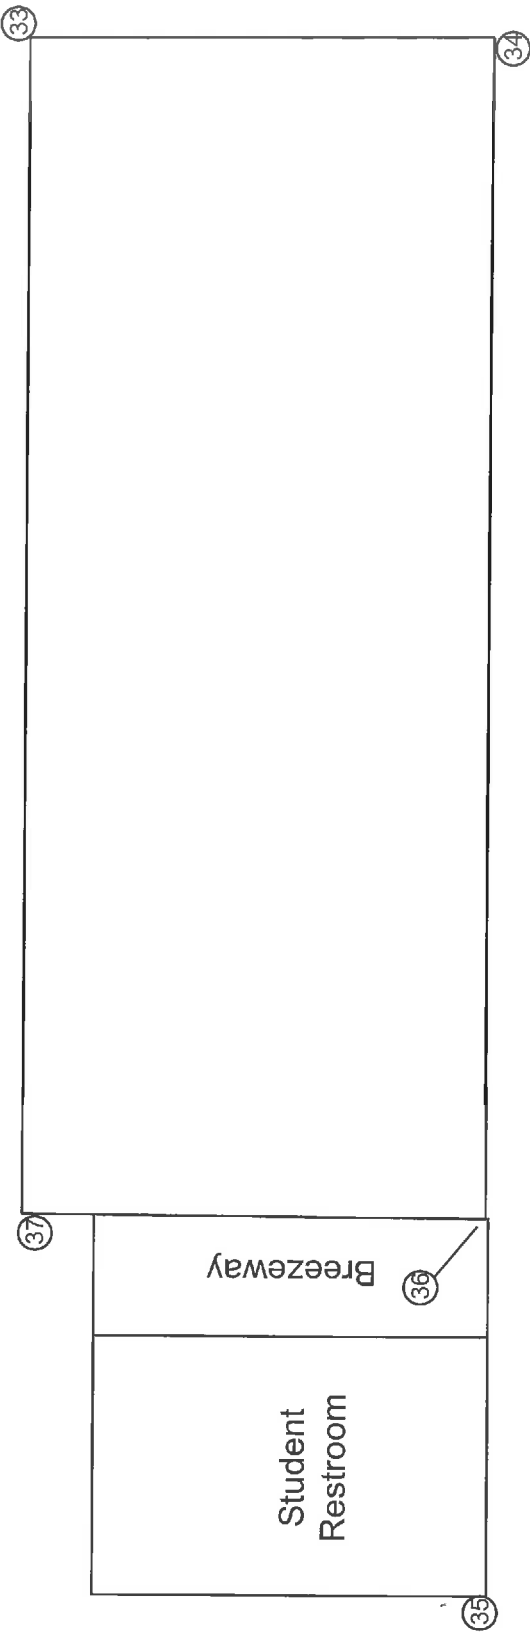
# Classroom Building (G) Room 15-18

| Homogeneous Material # | Material Description | Material Location | Estimated Quantity | Condition <sup>P</sup> | Type <sup>Q</sup> | Friable | Percent Damaged | Sample Number | Sample Location | Analytical Results |
|---|---|---|---|---|---|---|---|---|---|---|
| 7 | Stucco | Throughout exterior walls and Breezeway ceilings | 2,500 Square Feet | G | Surf. | No | 0 | 2002070027RK-33 | East wall, north end | NAD <sup>S</sup> |

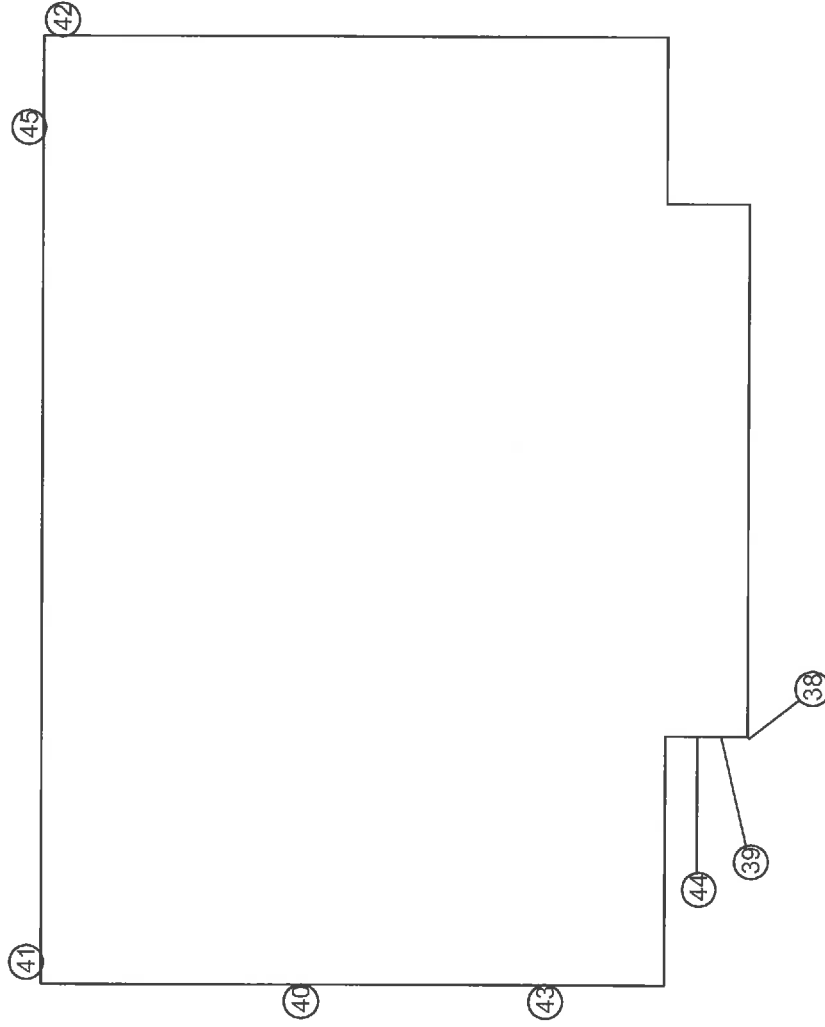
# Classroom Building (H) Room 19-20

| Homogeneous Material # | Material Description | Material Location | Estimated Quantity | Condition <sup>P</sup> | Type <sup>Q</sup> | Friable | Percent Damaged | Sample Number | Sample Location | Analytical Results |
|---|---|---|---|---|---|---|---|---|---|---|
| 8 | Stucco | Throughout exterior walls | 1,500 Square Feet | G | Surf. | No | 0 | 2002070027RK-38 | South wall, west end | NAD |
| 9 | Window putty | Throughout exterior windows | 330 Linear Feet | G | Misc. | No | <1 | 2002070027RK-42 | East wall, north end | NAD |

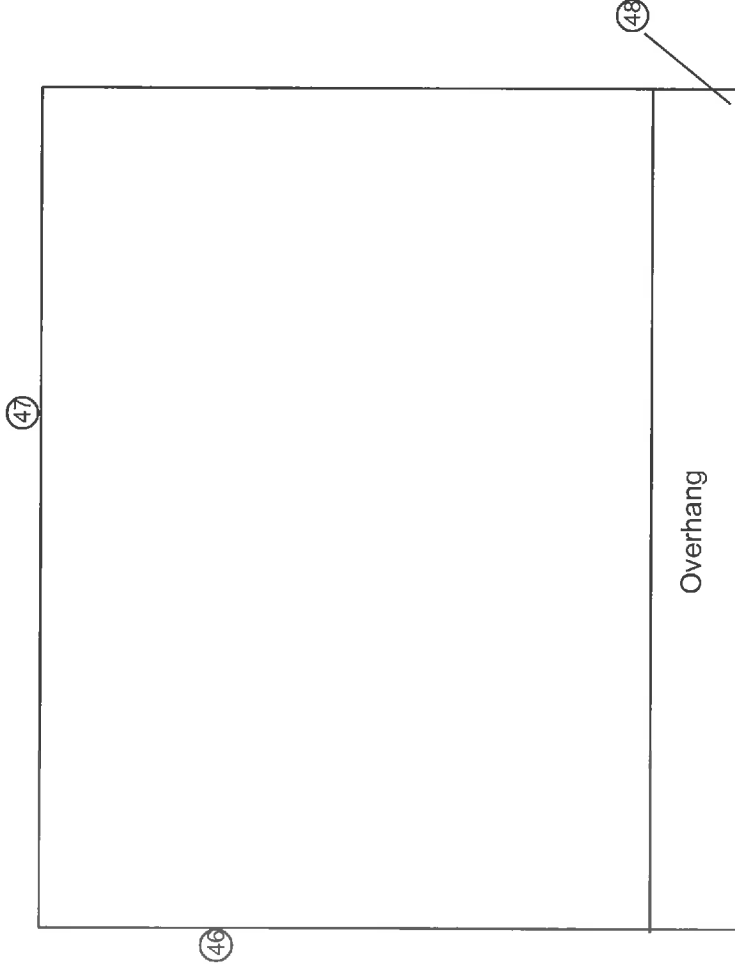
# Staff Restroom

| Homogeneous Material # | Material Description | Material Location | Estimated Quantity | Condition <sup>T</sup> | Type <sup>U</sup> | Friable | Percent Damaged | Sample Number | Sample Location | Analytical Results |
|---|---|---|---|---|---|---|---|---|---|---|
| 9 | Stucco | Throughout exterior walls and overhangs | 700 Square Feet | G | Surf. | No | 0 | 2002070027RK-46 | West | NAD <sup>W</sup> |

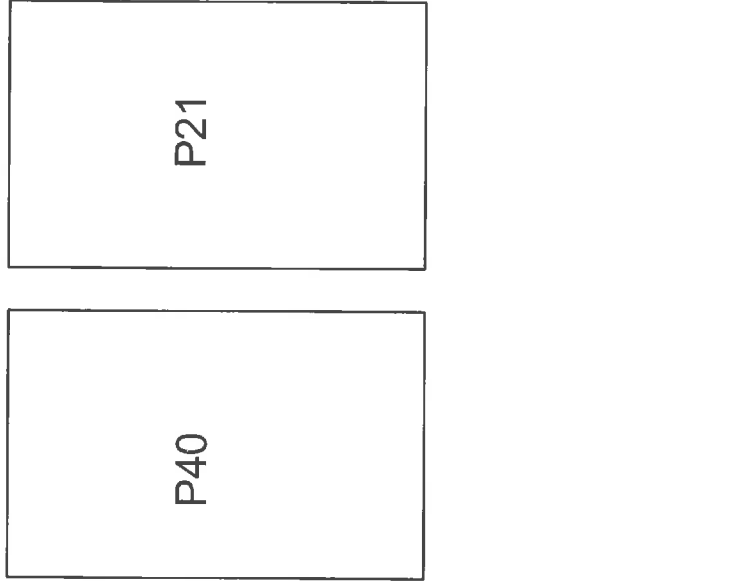
# Portables

| Homogeneous Material # | Material Description | Material Location | Estimated Quantity | Condition <sup>T</sup> | Type <sup>U</sup> | Friable | Percent Damaged | Sample Number | Sample Location | Analytical Results |
|---|---|---|---|---|---|---|---|---|---|---|
| No suspect asbestos-containing materials were identified on the exterior walls or windows of the Portables P21, P22, P23, P24, P25, P26, P27, P28, P29, P30 and P40. | | | | | | | | | | |

<sup>Y</sup> NOTE: 1) Portables P21, P22, P23, P24, P25, P26, P27, P28, P29, P30 and P40 have exterior wood walls and no window putty.
