## LIMITED ASBESTOS INSPECTION REPORT

MUSCATEL MIDDLE SCHOOL  
PAINTING PROJECT  
4201 IVAR AVENUE  
ROSEMEAD, CALIFORNIA 91770

Project Number EE 20-Z0046-0028  
March 20, 2020

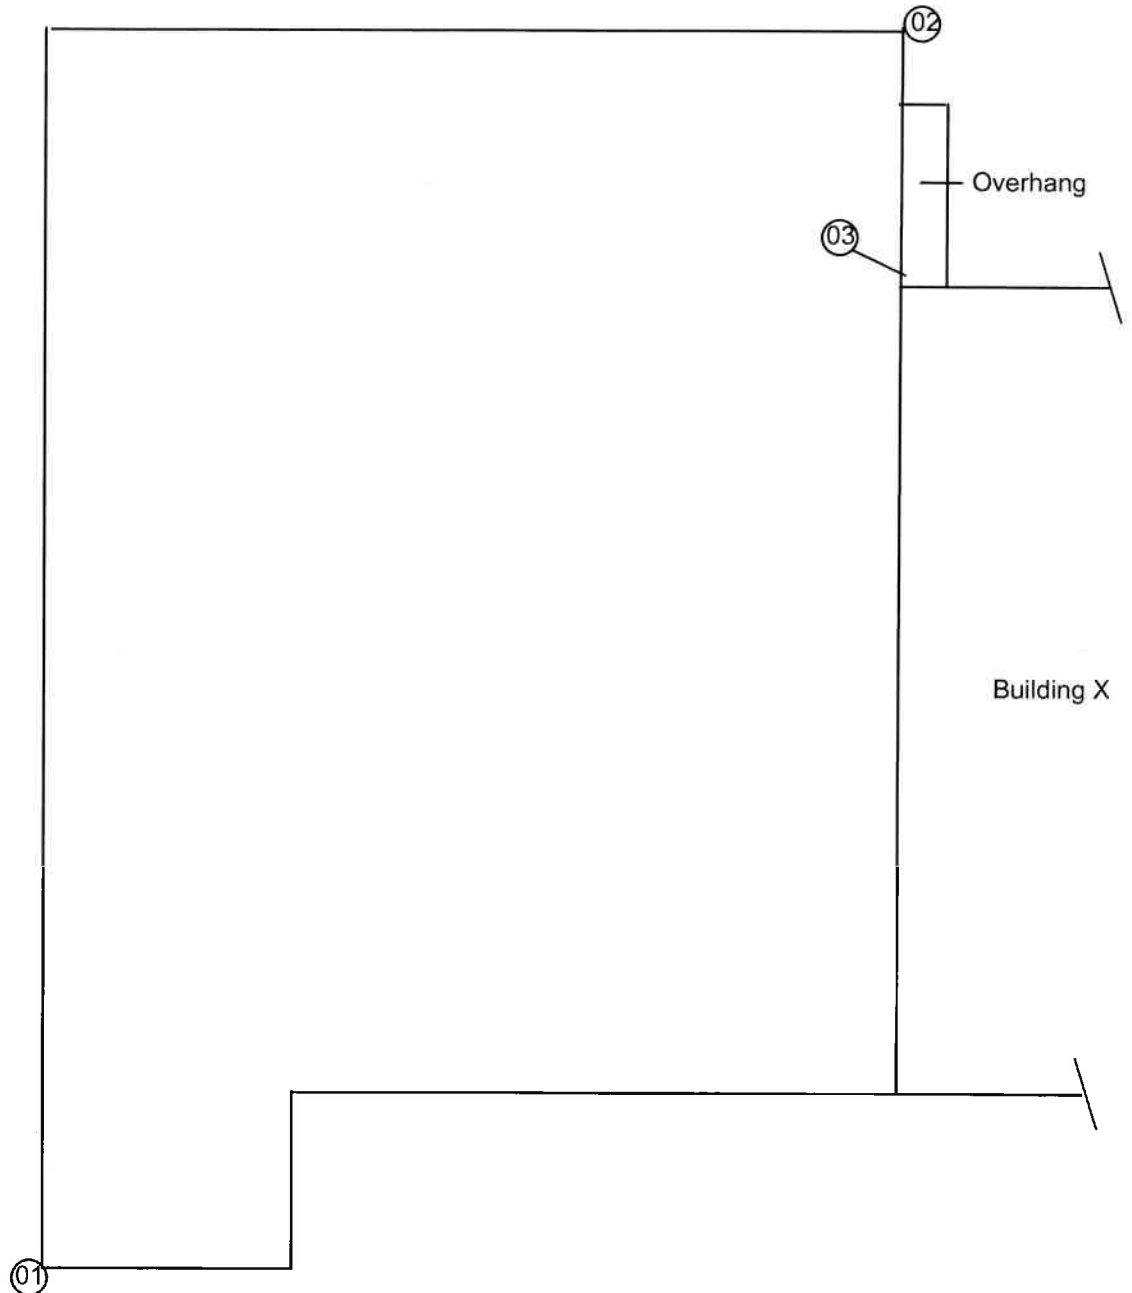
# Building A (Administration)

| Homogeneous Material # | Material Description | Material Location | Estimated Quantity | Condition <sup>A</sup> | Type <sup>B</sup> | Friable | Percent Damaged | Sample Number | Sample Location | Analytical Results |
|---|---|---|---|---|---|---|---|---|---|---|
| 1 | Stucco | Throughout exterior upper walls and overhangs | 750 Square Feet | G | Surf. | No | 0 | 2002180028TGK-01 | Southwest | NAD <sup>D</sup> |
| | | | | | | | | 2002180028TGK-02 | Northeast | NAD |
| | | | | | | | | 2002180028TGK-03 | South end of east overhang | NAD |

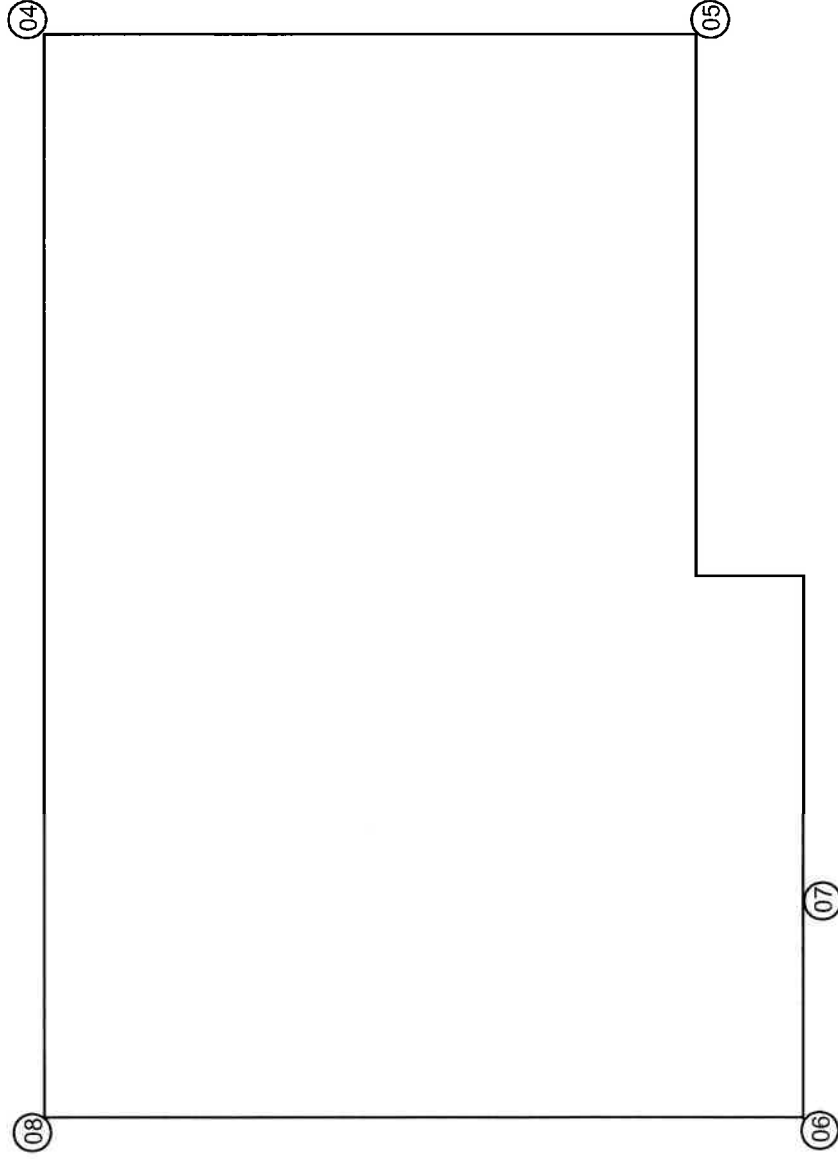
# Building B (Weight Room)

| Homogeneous Material # | Material Description | Material Location | Estimated Quantity | Condition <sup>A</sup> | Type <sup>B</sup> | Friable | Percent Damaged | Sample Number | Sample Location | Analytical Results |
|---|---|---|---|---|---|---|---|---|---|---|
| 2 | Stucco | Throughout exterior walls | 1,560 Square Feet | G | Surf. | No | 0 | 2002180028TGK-04 | Northeast | NAD |
| | | | | | | | | 2002180028TGK-05 | Southeast | NAD |
| | | | | | | | | 2002180028TGK-06 | Southwest | NAD |
| | | | | | | | | 2002180028TGK-07 | South | NAD |
| | | | | | | | | 2002180028TGK-08 | Northwest | NAD |

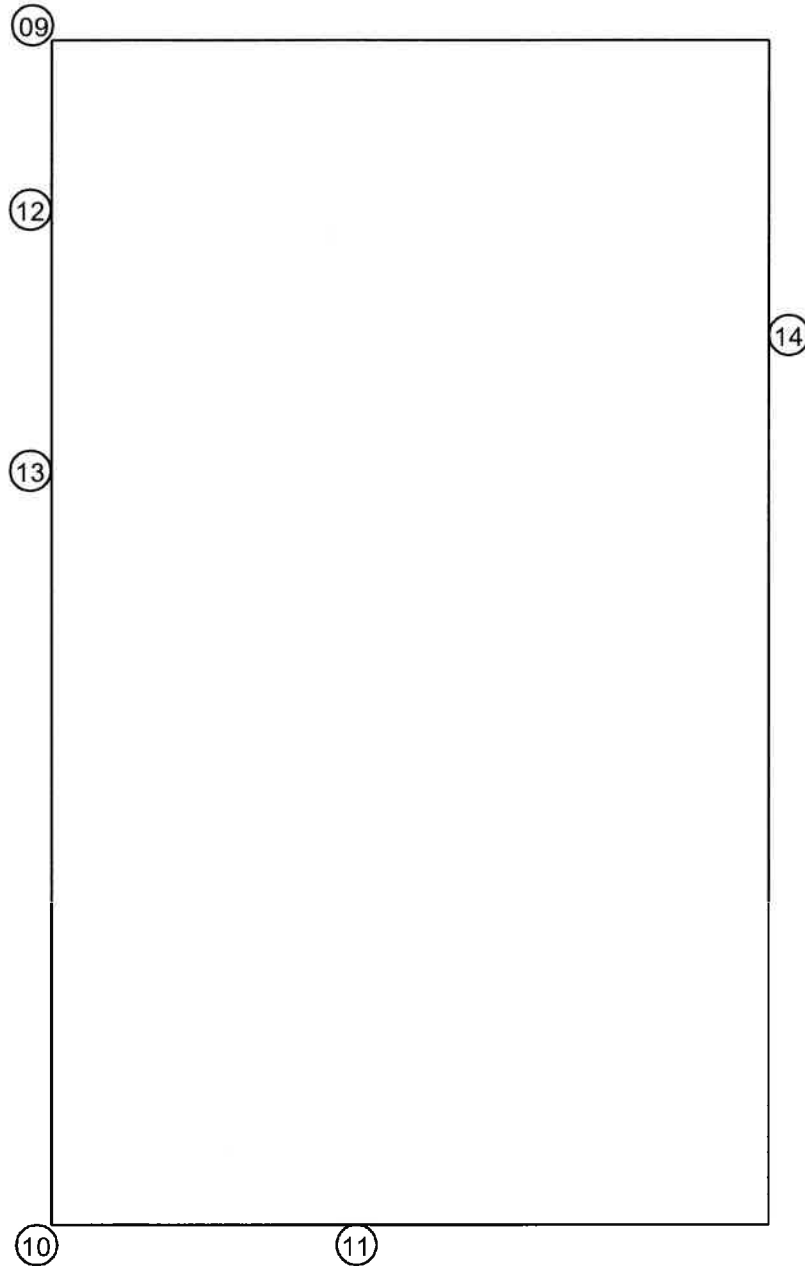
Building C  
(Library/Computer Room)

| Homogeneous Material # | Material Description | Material Location | Estimated Quantity | Condition <sup>F</sup> | Type <sup>G</sup> | Friable | Percent Damaged | Sample Number | Sample Location | Analytical Results |
|---|---|---|---|---|---|---|---|---|---|---|
| 3 | Stucco | Throughout exterior upper walls and overhangs | 880 Square Feet | G | Surf. | No | 0 | 2002190028TGK-09 | Northwest | NAD <sup>I</sup> |
| 4 | Window putty | Exterior side of window frames at east and west side of building | 28 Windows<br>28 Square Foot | G | Misc. | No | 0 | 2002190028TGK-12 | North end of west side | 2% Chrysotile |
| | | | | | | | | 2002190028TGK-13 | West side | NA/PS <sup>J</sup> |
| | | | | | | | | 2002190028TGK-14 | East side | NA/PS |

Normally, asbestos-containing material found to be in good condition is not considered a hazard, unless it is disturbed. Prior to the start of any activity, such as remodeling, demolition, or renovation, that might disturb these materials, a Certified Asbestos Consultant should be contracted to design and monitor the project. A California-licensed asbestos contractor should be hired to complete the asbestos abatement procedures.

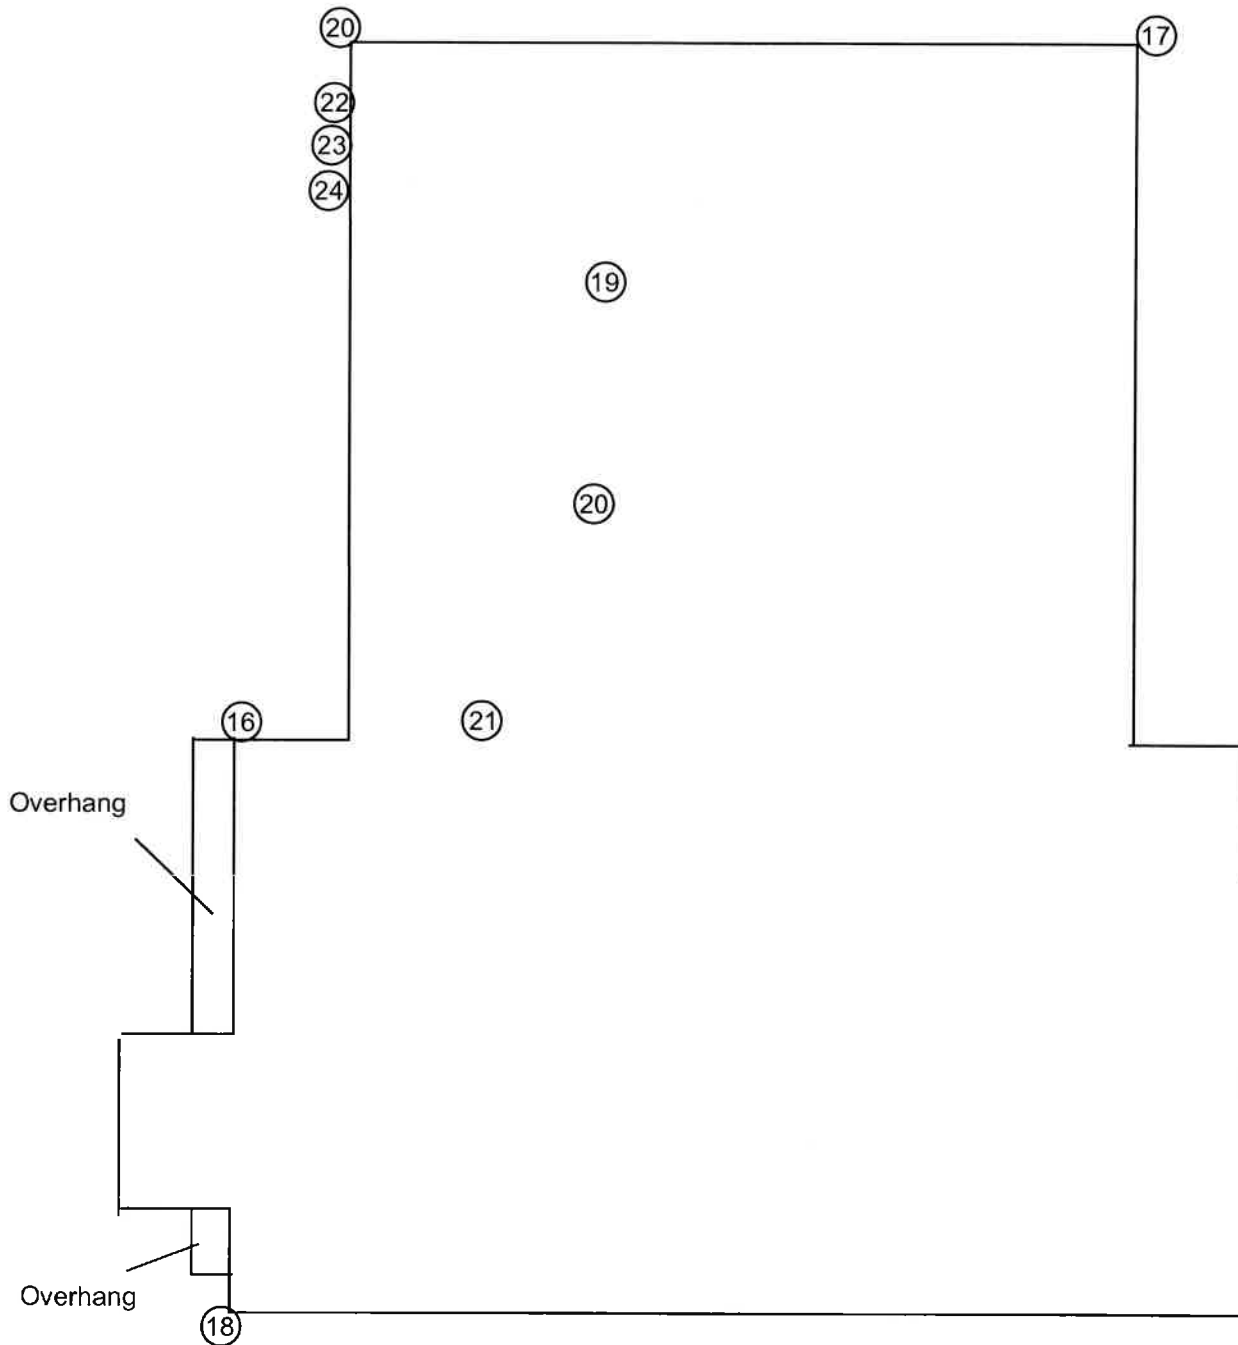
# Building D (Multi-Purpose Building)

| Homogeneous Material # | Material Description | Material Location | Estimated Quantity | Condition <sup>K</sup> | Type <sup>L</sup> | Friable | Percent Damaged | Sample Number | Sample Location | Analytical Results |
|---|---|---|---|---|---|---|---|---|---|---|
| 5 | Stucco | Throughout exterior walls and overhangs at west side | 9,500 Square Feet | G | Surf. | No | 0 | 2002190028TGK-15 | Northwest | NAD <sup>M</sup> |
| 6 | Window putty | Exterior side of window frames at north end of west wall at Speech Office | 8 Windows | G | Misc. | No | 0 | 2002190028TGK-23 | North end of west wall | NAD |

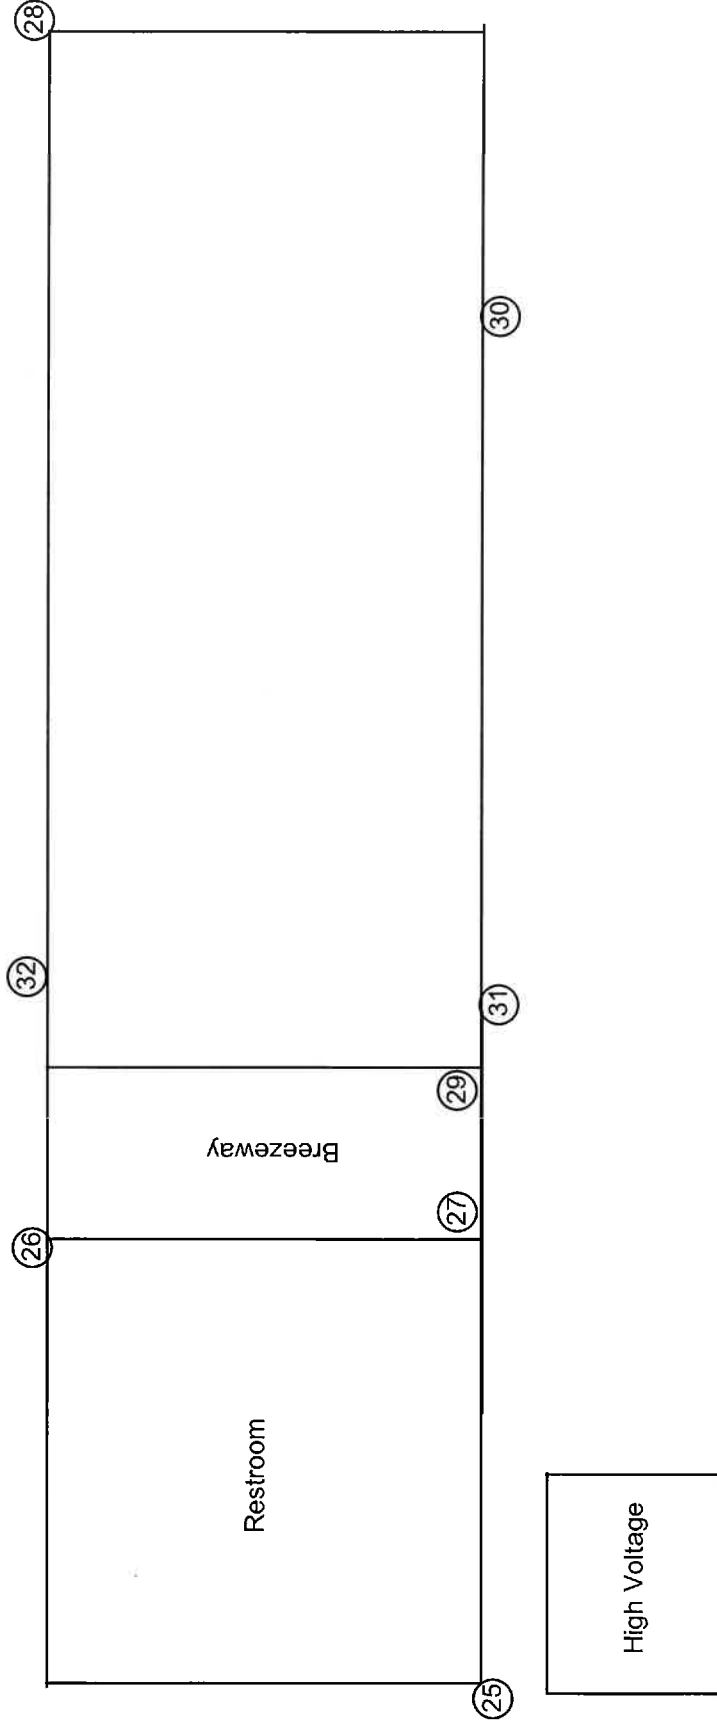
# Building E (Rooms 6-9/Restroom)

| Homogeneous Material # | Material Description | Material Location | Estimated Quantity | Condition <sup>N</sup> | Type <sup>o</sup> | Friable | Percent Damaged | Sample Number | Sample Location | Analytical Results |
|---|---|---|---|---|---|---|---|---|---|---|
| 7 | Stucco | Throughout exterior upper walls and Breezeway ceiling | 3,200 Square Feet | G | Surf. | No | 0 | 2002190028TGK-25 | Restroom Bldg., southwest | NAD <sup>Q</sup> |
| 8 | Window putty | Exterior side of window frames at north and south walls of Classrooms | 152 Windows | G | Misc. | No | 0 | 2002190028TGK-30 | South side of Room 9 | NAD |

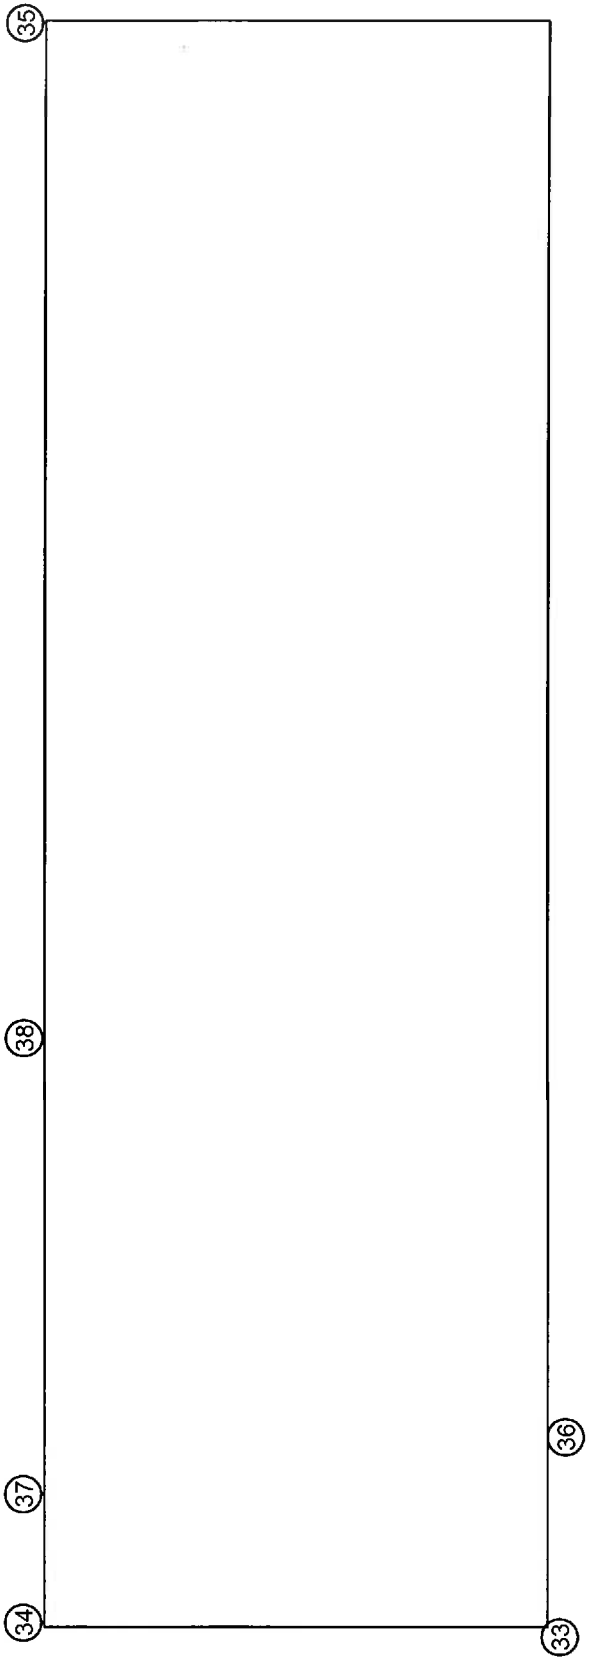
# Building F (Rooms 10-13)

| Homogeneous Material # | Material Description | Material Location | Estimated Quantity | Condition <sup>R</sup> | Type <sup>S</sup> | Friable | Percent Damaged | Sample Number | Sample Location | Analytical Results |
|---|---|---|---|---|---|---|---|---|---|---|
| 9 | Stucco | Throughout exterior upper walls and Breezeway ceiling | 920 Square Feet | G | Surf. | No | 0 | 2002190028TGK-33 | Southwest | NAD <sup>U</sup> |
| 10 | Window putty | Exterior side of window frames at north and south walls of Classrooms | 152 Windows | G | Misc. | No | 0 | 2002190028TGK-36 | South side of Room 10 | NAD |

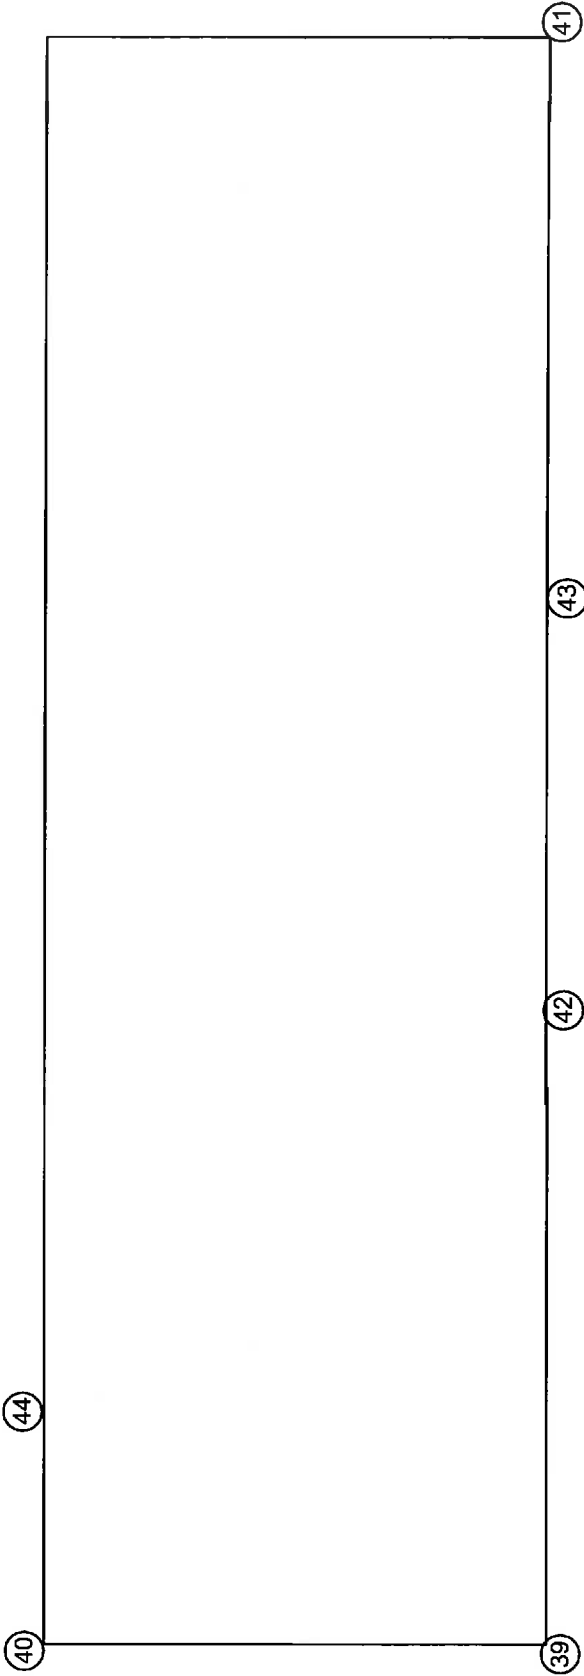
# Building G (Rooms 14-17)

| Homogeneous Material # | Material Description | Material Location | Estimated Quantity | Condition <sup>v</sup> | Type <sup>w</sup> | Friable | Percent Damaged | Sample Number | Sample Location | Analytical Results |
|---|---|---|---|---|---|---|---|---|---|---|
| 11 | Stucco | Throughout exterior upper walls and Breezeway ceiling | 920 Square Feet | G | Surf. | No | 0 | 2002190028TGK-39 | Southwest | NAD <sup>y</sup> |
| 12 | Window putty | Exterior side of window frames at north and south walls of Classrooms | 152 Windows | G | Misc. | No | 0 | 2002190028TGK-42 | South side of Room 15 | NAD |
