## LIMITED LEAD-BASED PAINT INSPECTION REPORT

JANSON ELEMENTARY SCHOOL  
ROOFING PROJECT  
8628 MARSHALL STREET  
ROSEMEAD, CALIFORNIA 91770

Project Number EE 18-Z0046-0048  
March 20, 2018

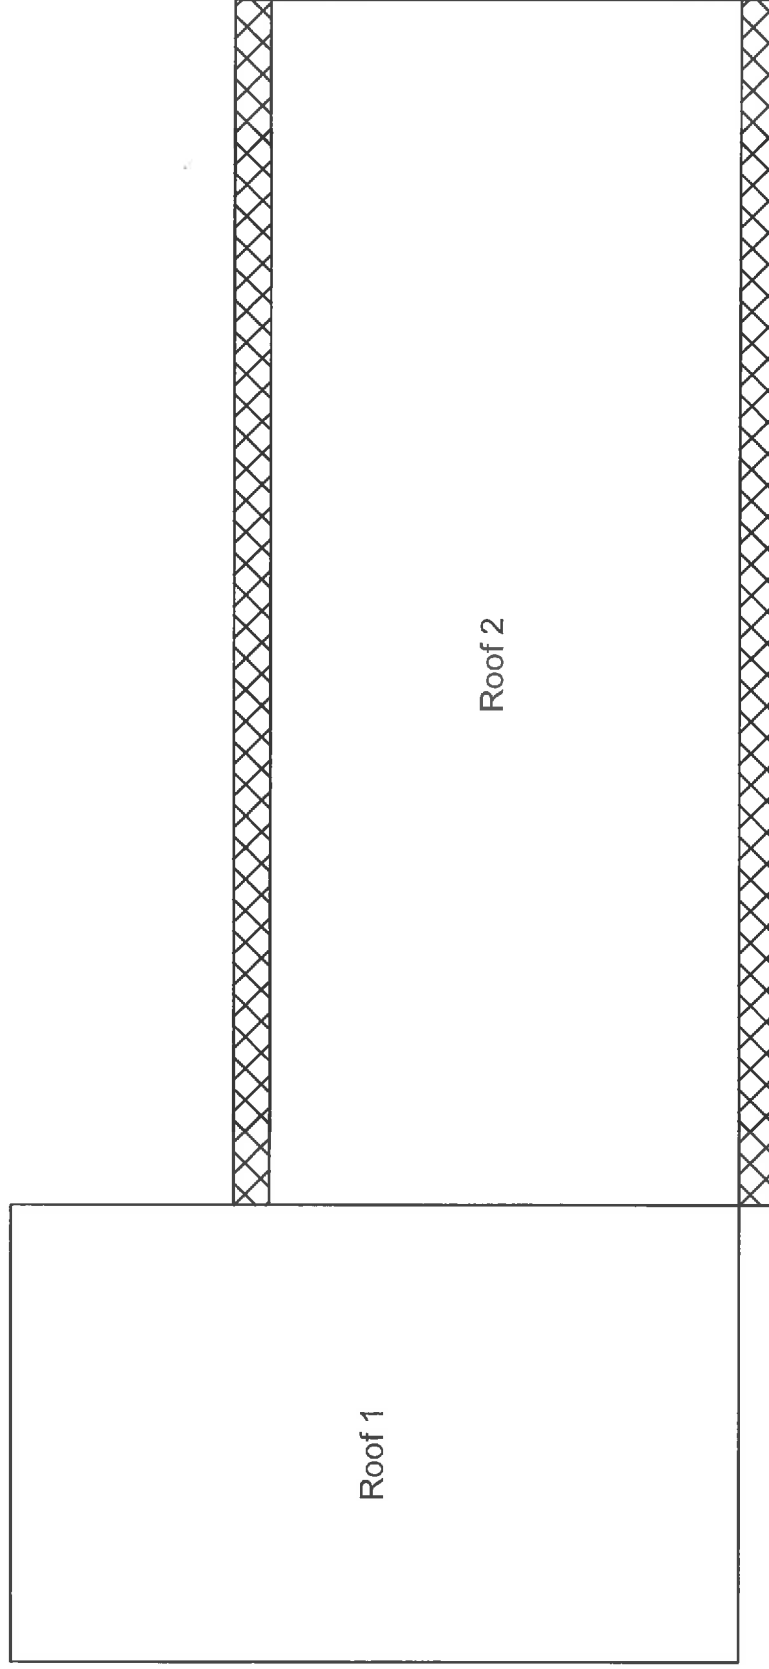
# Administration Building

| <b>XRF SAMPLE ANALYSIS DATA</b><br>Janson Elementary School<br>8628 Marshall Street<br>Rosemead, California 91770 | | | | |
|---|---|---|---|---|
| Rooftop no. 2 | Overhang | Wood | 365 Square Feet | 3.5 |

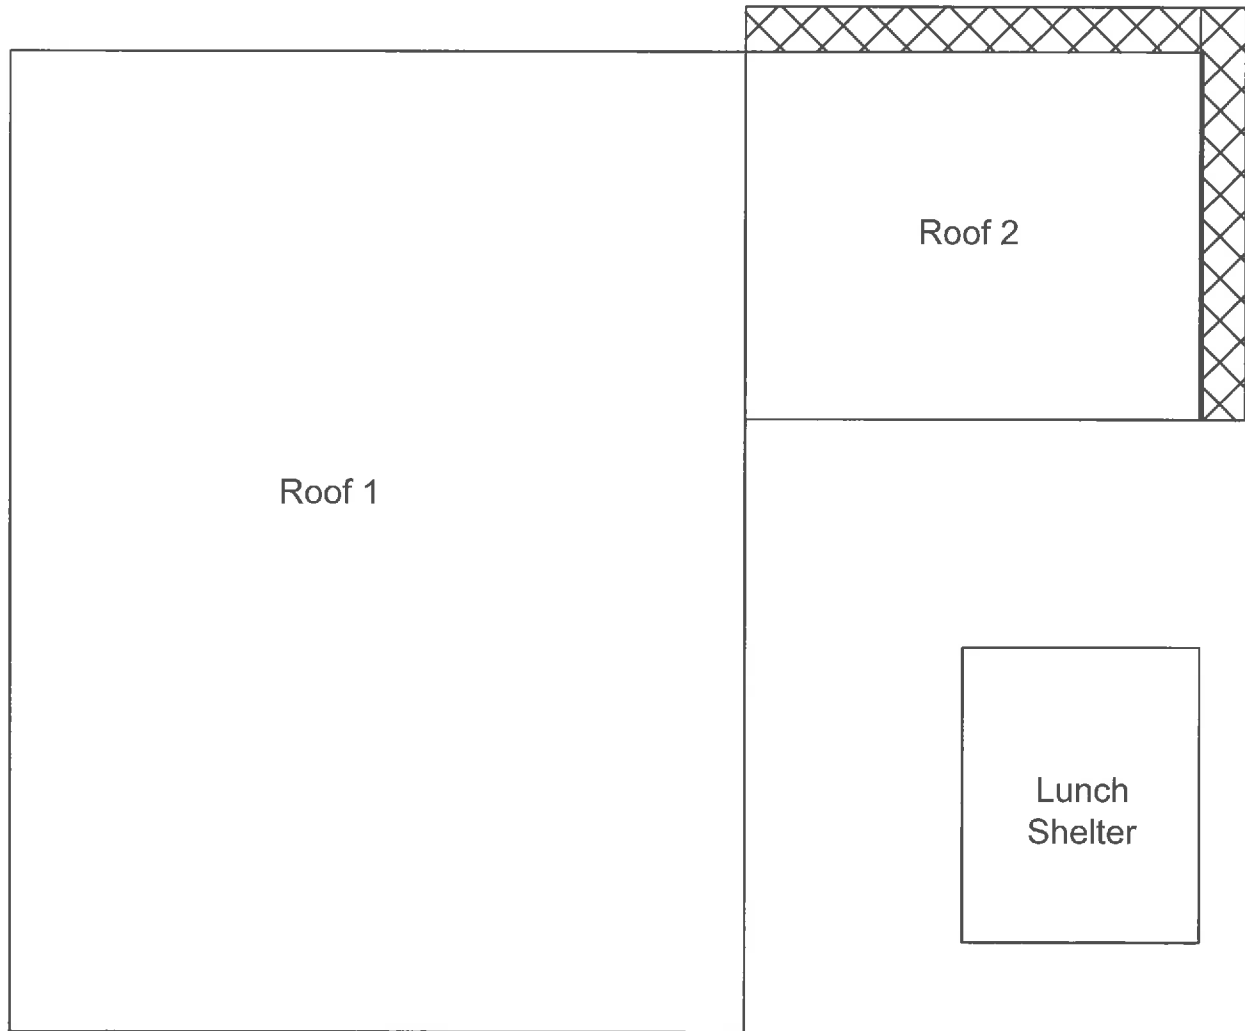
# Classroom Building ( Room 4) and Lunch Shelter

| <b>XRF SAMPLE ANALYSIS DATA</b><br>Janson Elementary School<br>8628 Marshall Street<br>Rosemead, California 91770 | | | | |
|---|---|---|---|---|
| Rooftop no. 2 | Overhang | Wood | 80 Square Feet | 3.7 |

- Wood Overhang

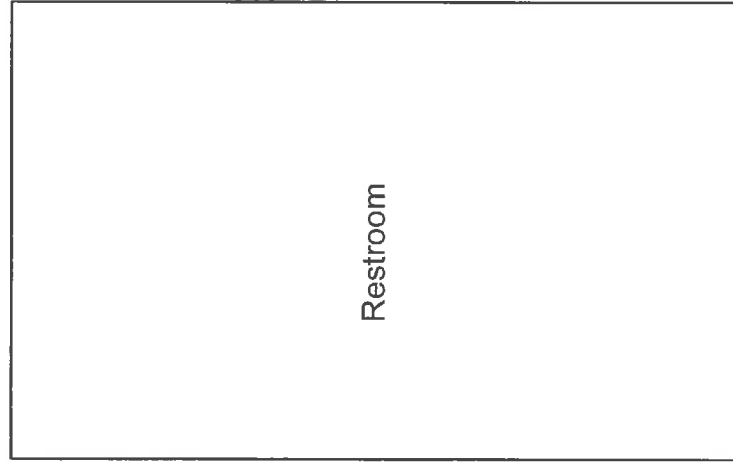
Classroom Building 10 through 13

| <b>XRF SAMPLE ANALYSIS DATA</b><br>Janson Elementary School<br>8628 Marshall Street<br>Rosemead, California 91770 | | | | |
|---|---|---|---|---|
| Exterior | Overhang | Wood | 520 Square Feet | 1.2 |

- Wood Overhang

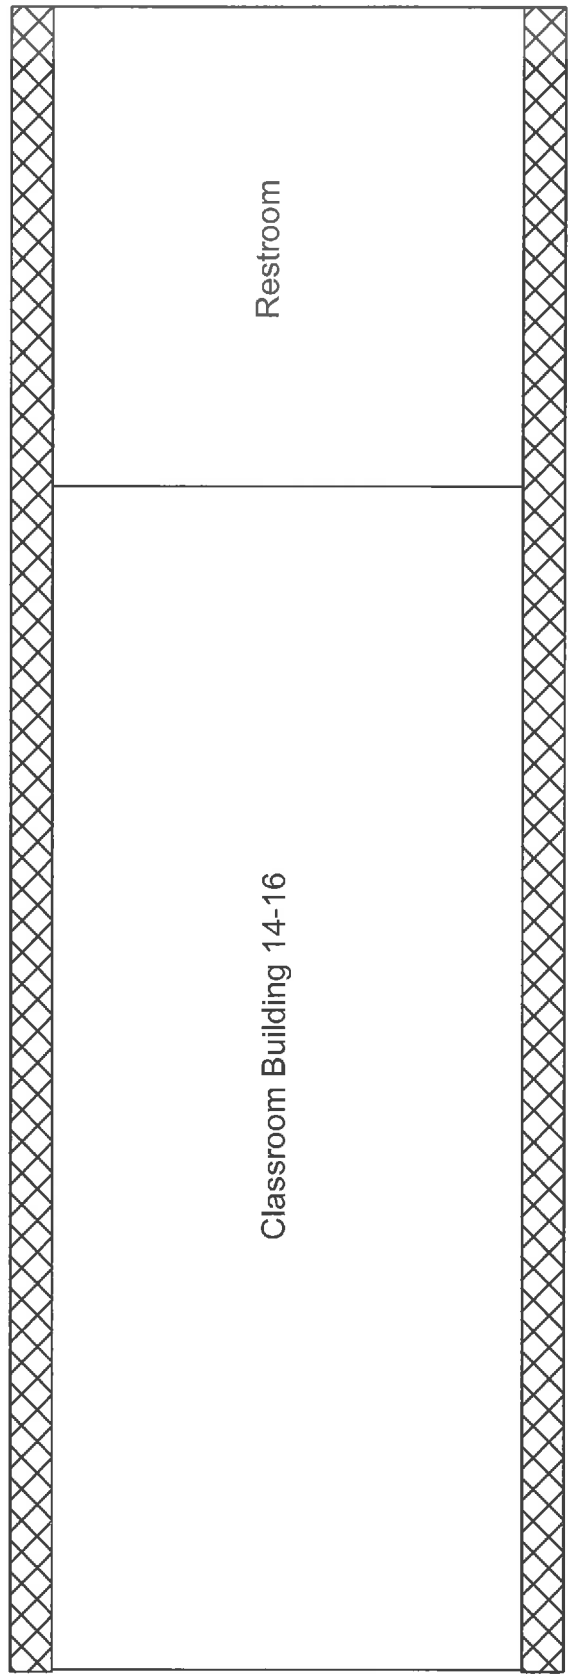
Classroom Building 14 through 16

| <b>XRF SAMPLE ANALYSIS DATA</b><br>Janson Elementary School<br>8628 Marshall Street<br>Rosemead, California 91770 | | | | |
|---|---|---|---|---|
| Exterior | Overhang | Wood | 360 Square Feet | 1.3 |

- Wood Overhang

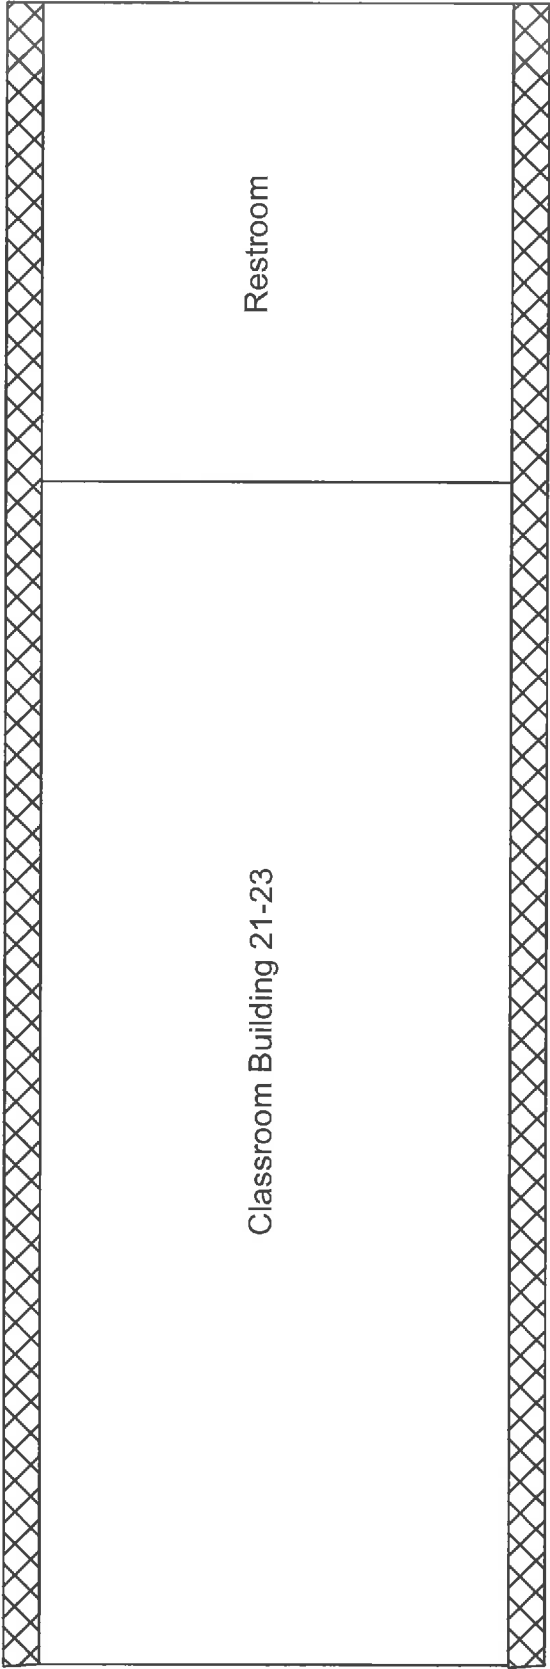
Classroom Building 21 through 23

| <b>XRF SAMPLE ANALYSIS DATA</b><br>Janson Elementary School<br>8628 Marshall Street<br>Rosemead, California 91770 | | | | |
|---|---|---|---|---|
| Exterior | Overhang | Wood | 360 Square Feet | 3.8 |

- Wood Overhang

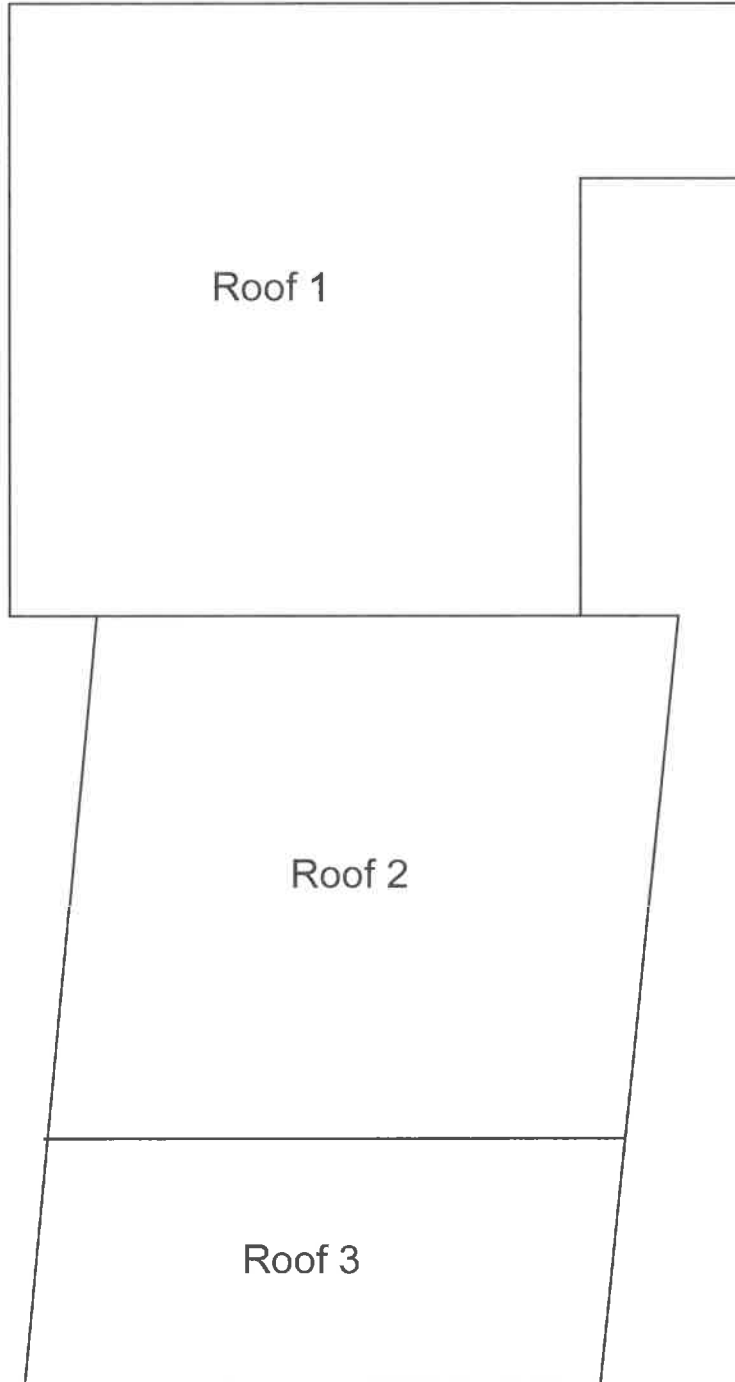
# MPR Building

| <b>XRF SAMPLE ANALYSIS DATA</b><br>Janson Elementary School<br>8628 Marshall Street<br>Rosemead, California 91770 | | | | |
|---|---|---|---|---|
| No regulated lead-based paint was identified on the surfaces or components anticipated to be impacted by the Roofing Project. | | | | |

**Info:** No Lead-Based Paint/Glaze Identified
