LIMITED LEAD-BASED PAINT INSPECTION REPORT

MUSCATEL MIDDLE SCHOOL
BUILDING L (PORTABLES 32 THROUGH 39 AND RESTROOM)
ROOFING PROJECT
4201 IVAR AVENUE
ROSEMEAD, CALIFORNIA 91770

Project Number EE 22-Z0046-0014
March 8, 2022

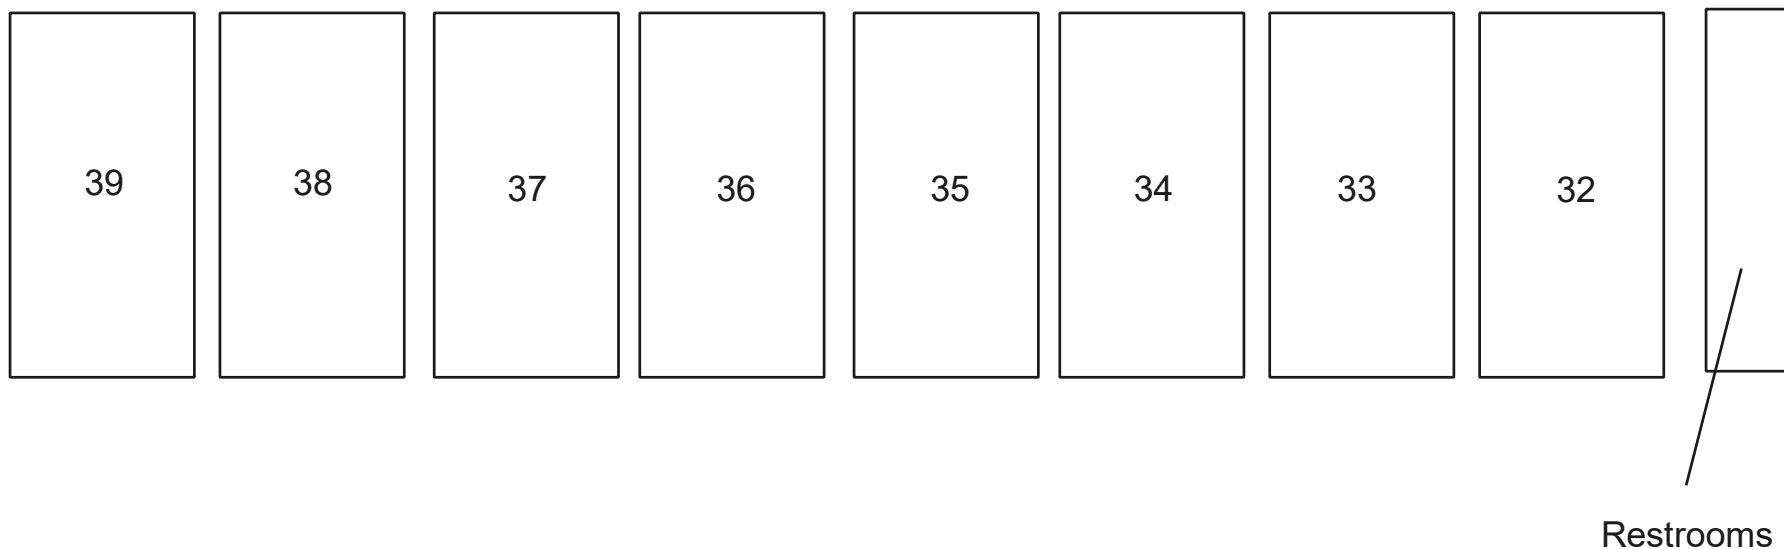
Building L (Portables 32 thru 39, Restroom) Roofs

Info: No Lead Based Paint Identified
