LIMITED LEAD-BASED PAINT/CERAMIC TILE INSPECTION REPORT

MUSCATEL MIDDLE SCHOOL
NEW SHADE STRUCTURE AND BUILDING E URINAL & DRINKING
FOUNTAIN
4201 IVAR AVENUE
ROSEMEAD, CALIFORNIA 91770

Project Number EE 23-Z0046-0030
March 13, 2023

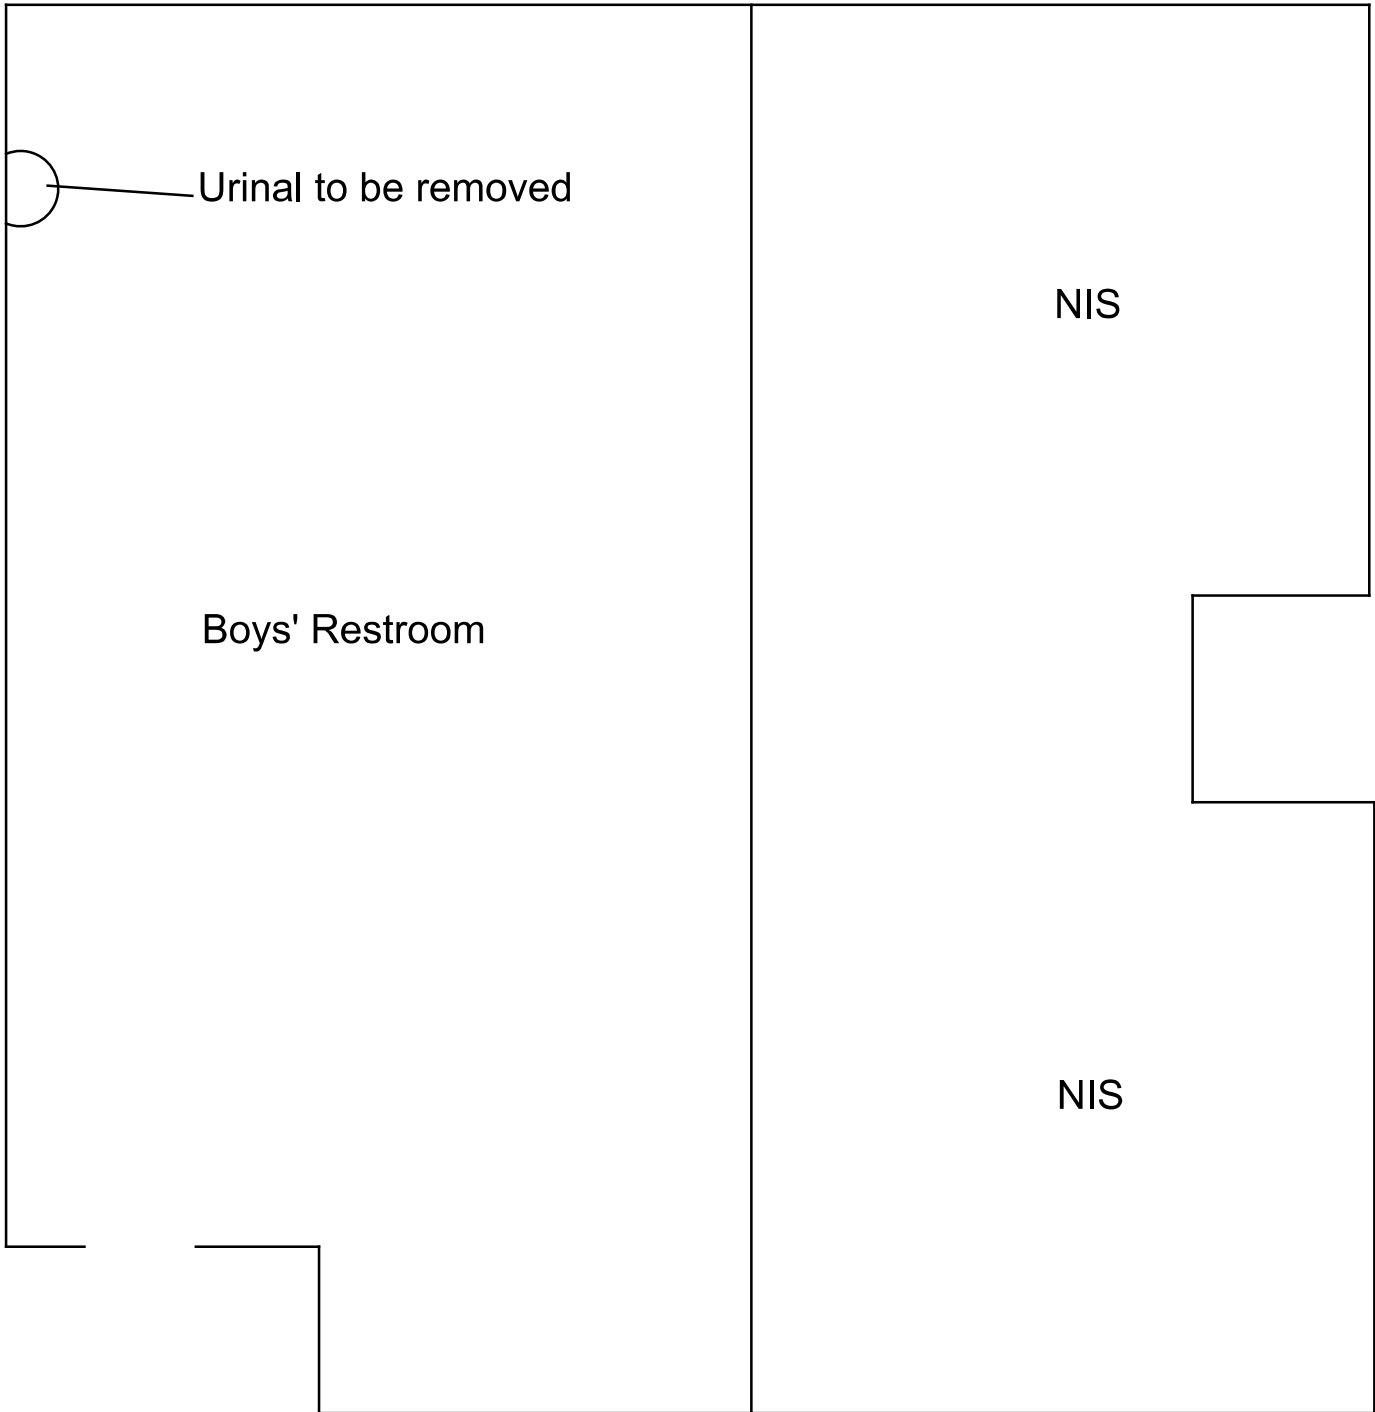
Building E Restrooms Interior

Info: No Lead-Based Paint/Glaze Identified
