RE: Pre-Demolition Asbestos and Lead in Paint Survey Report

Janson Elementary School
Playground and Relocatable Project
8628 Marshall Street
Rosemead, California 91770

CES Project No.: 24-RSMD.01

PRE-DEMOLITION ASBESTOS AND LEAD IN PAINT SURVEY
JANSON ELEMENTARY SCHOOL
PLAYGROUND DEMOLITION PROJECT

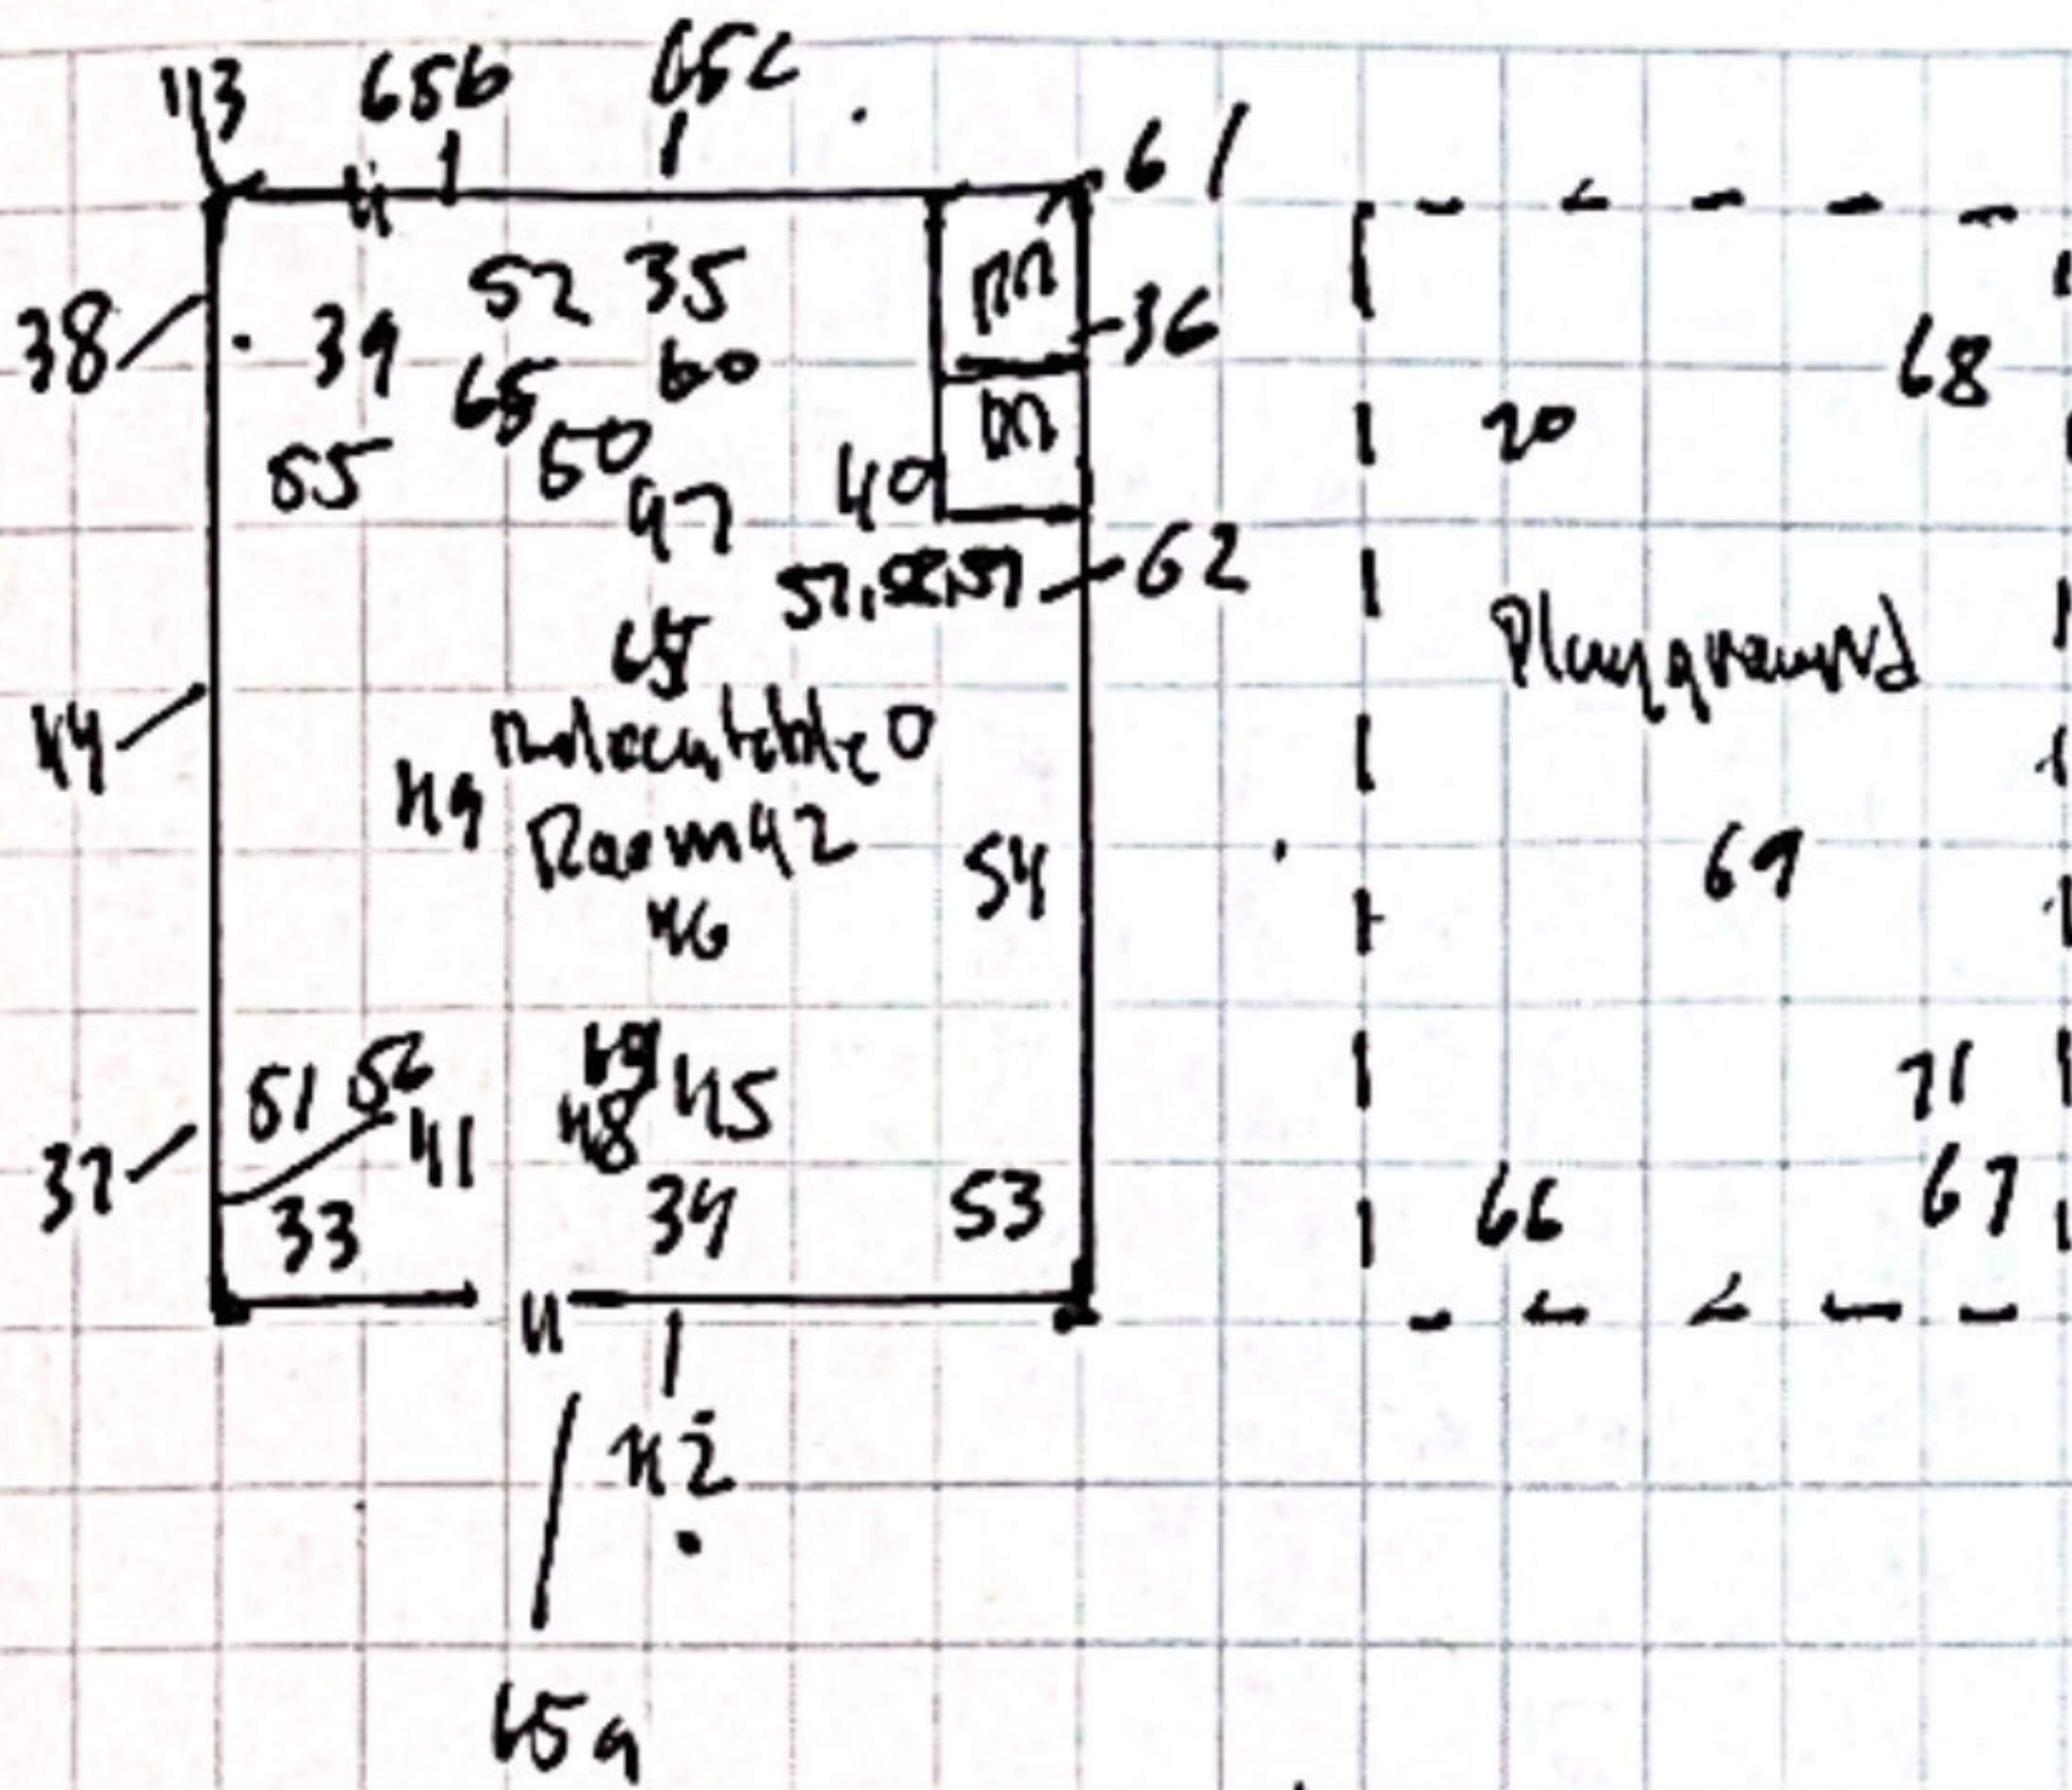
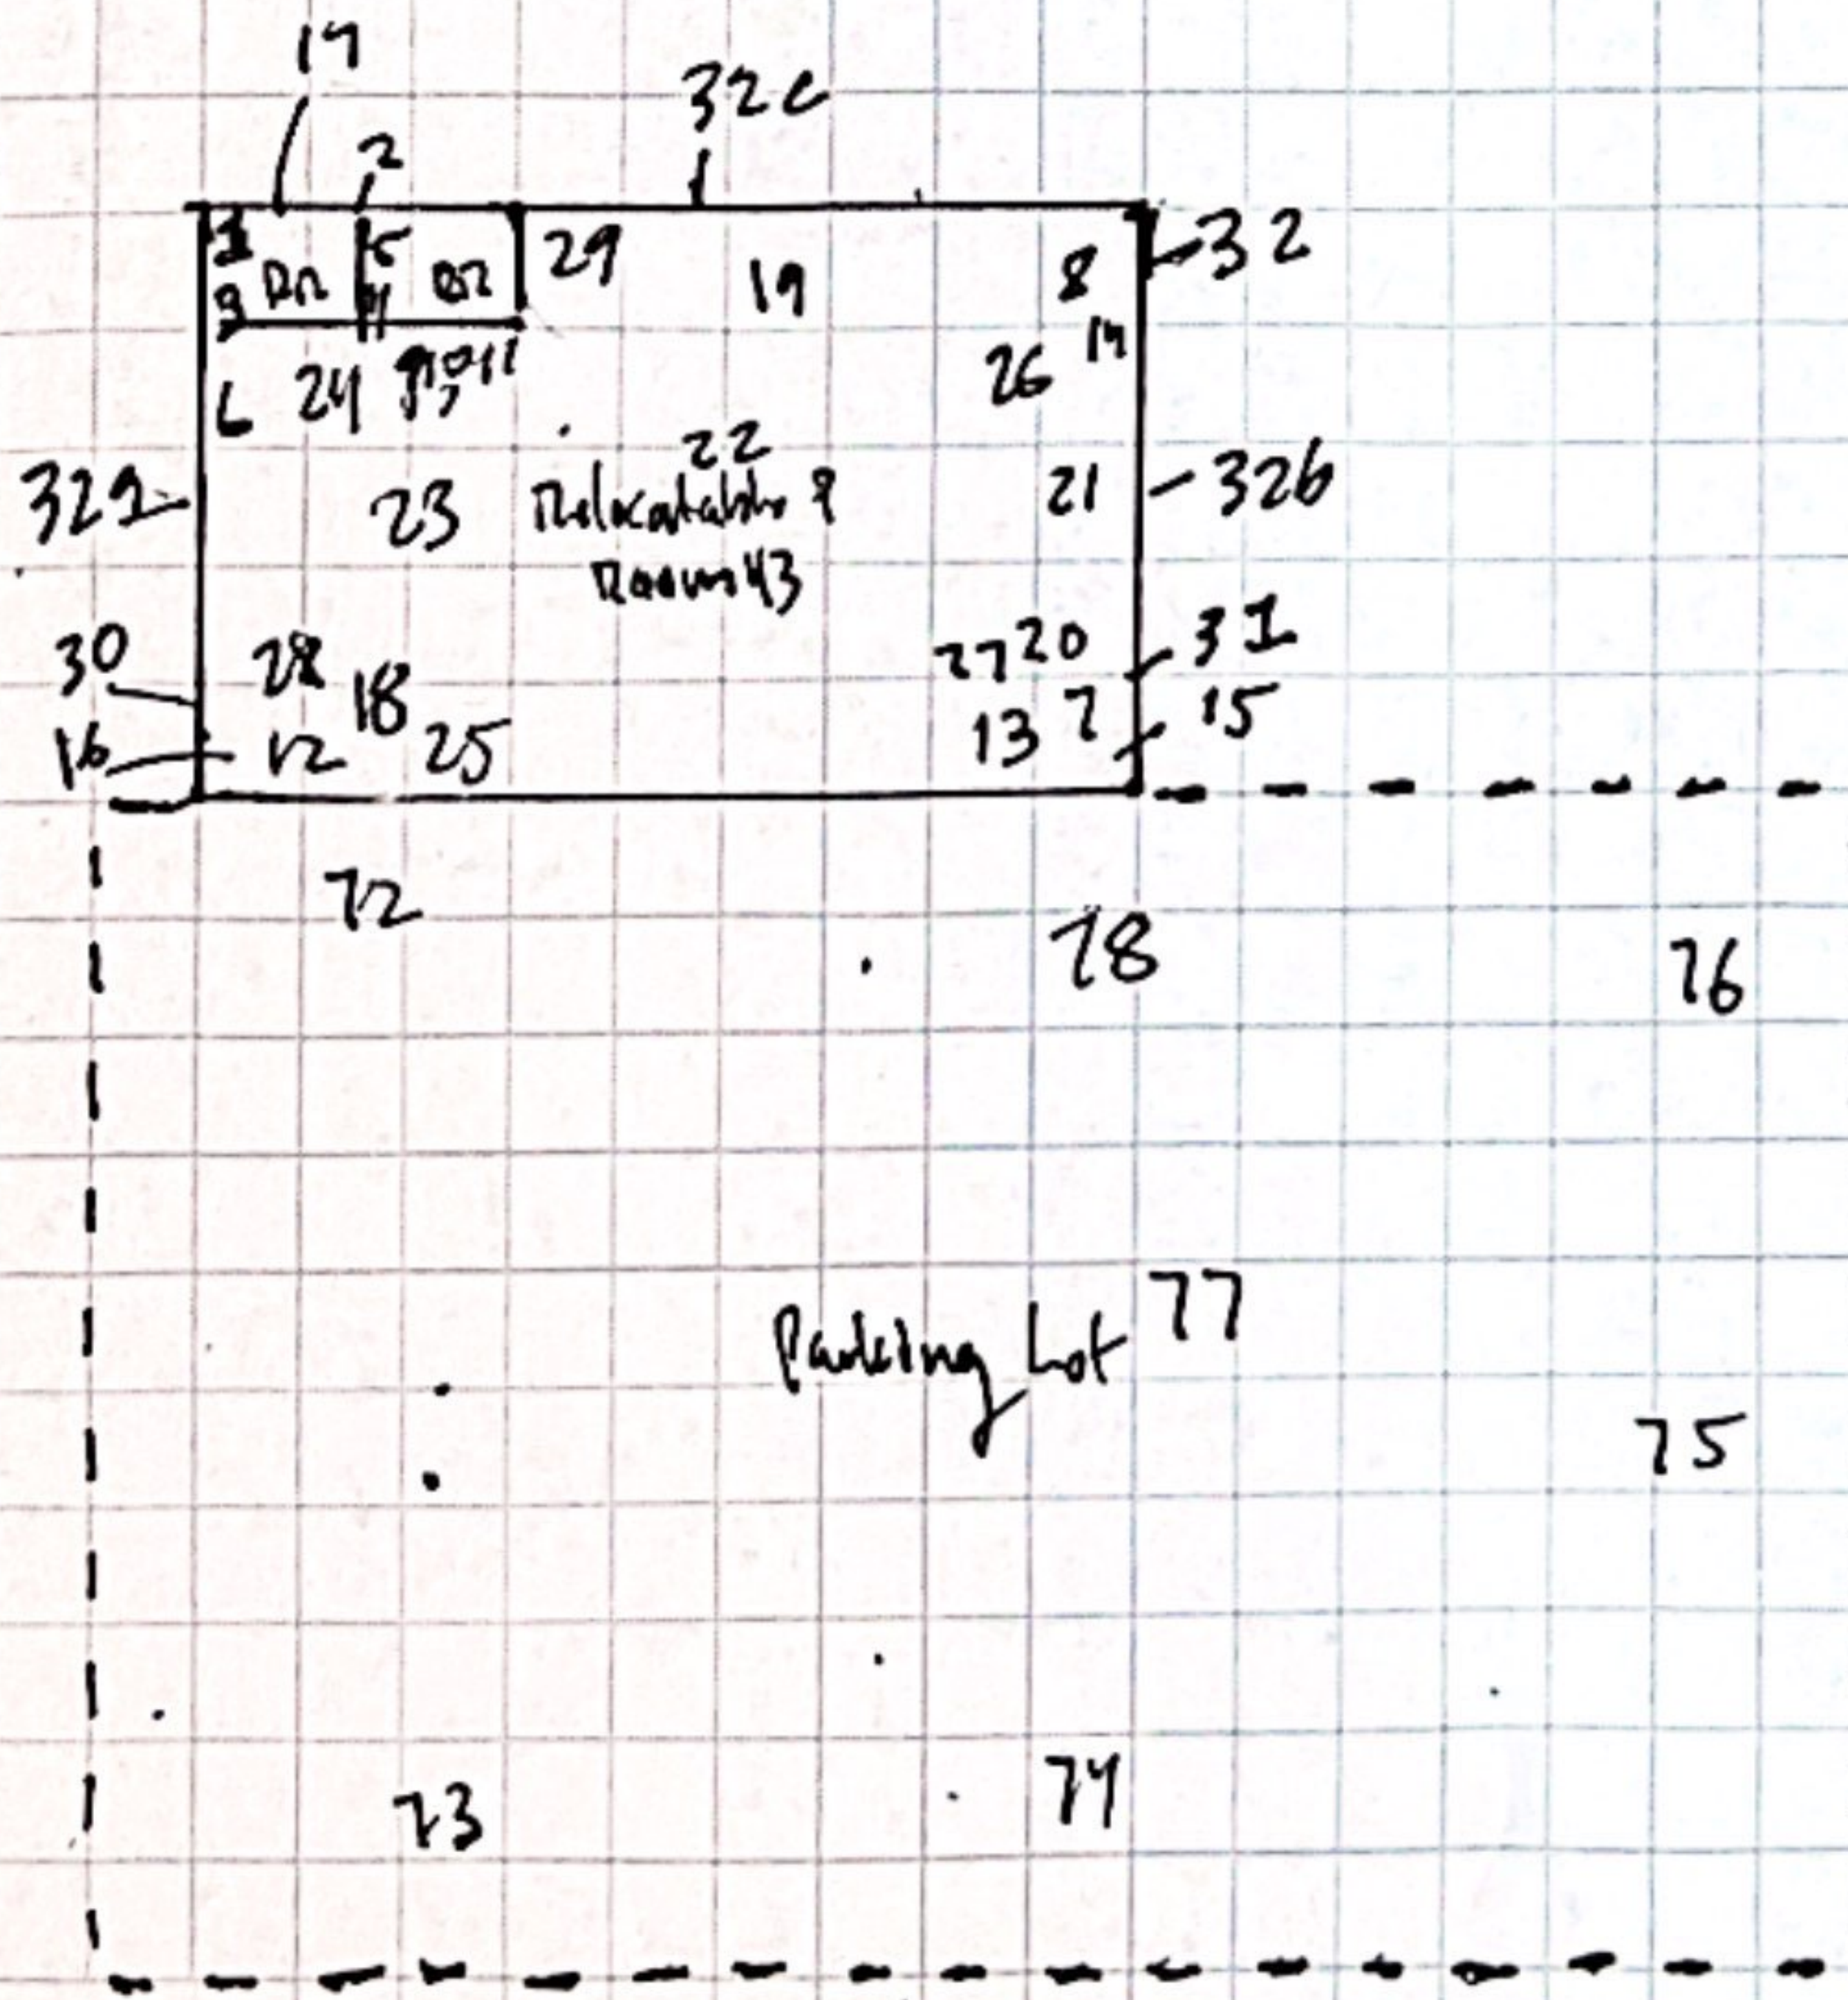
Bulk Samples: 1-32
32a, b, c -
33-65 -
65a, b, c,
66-78

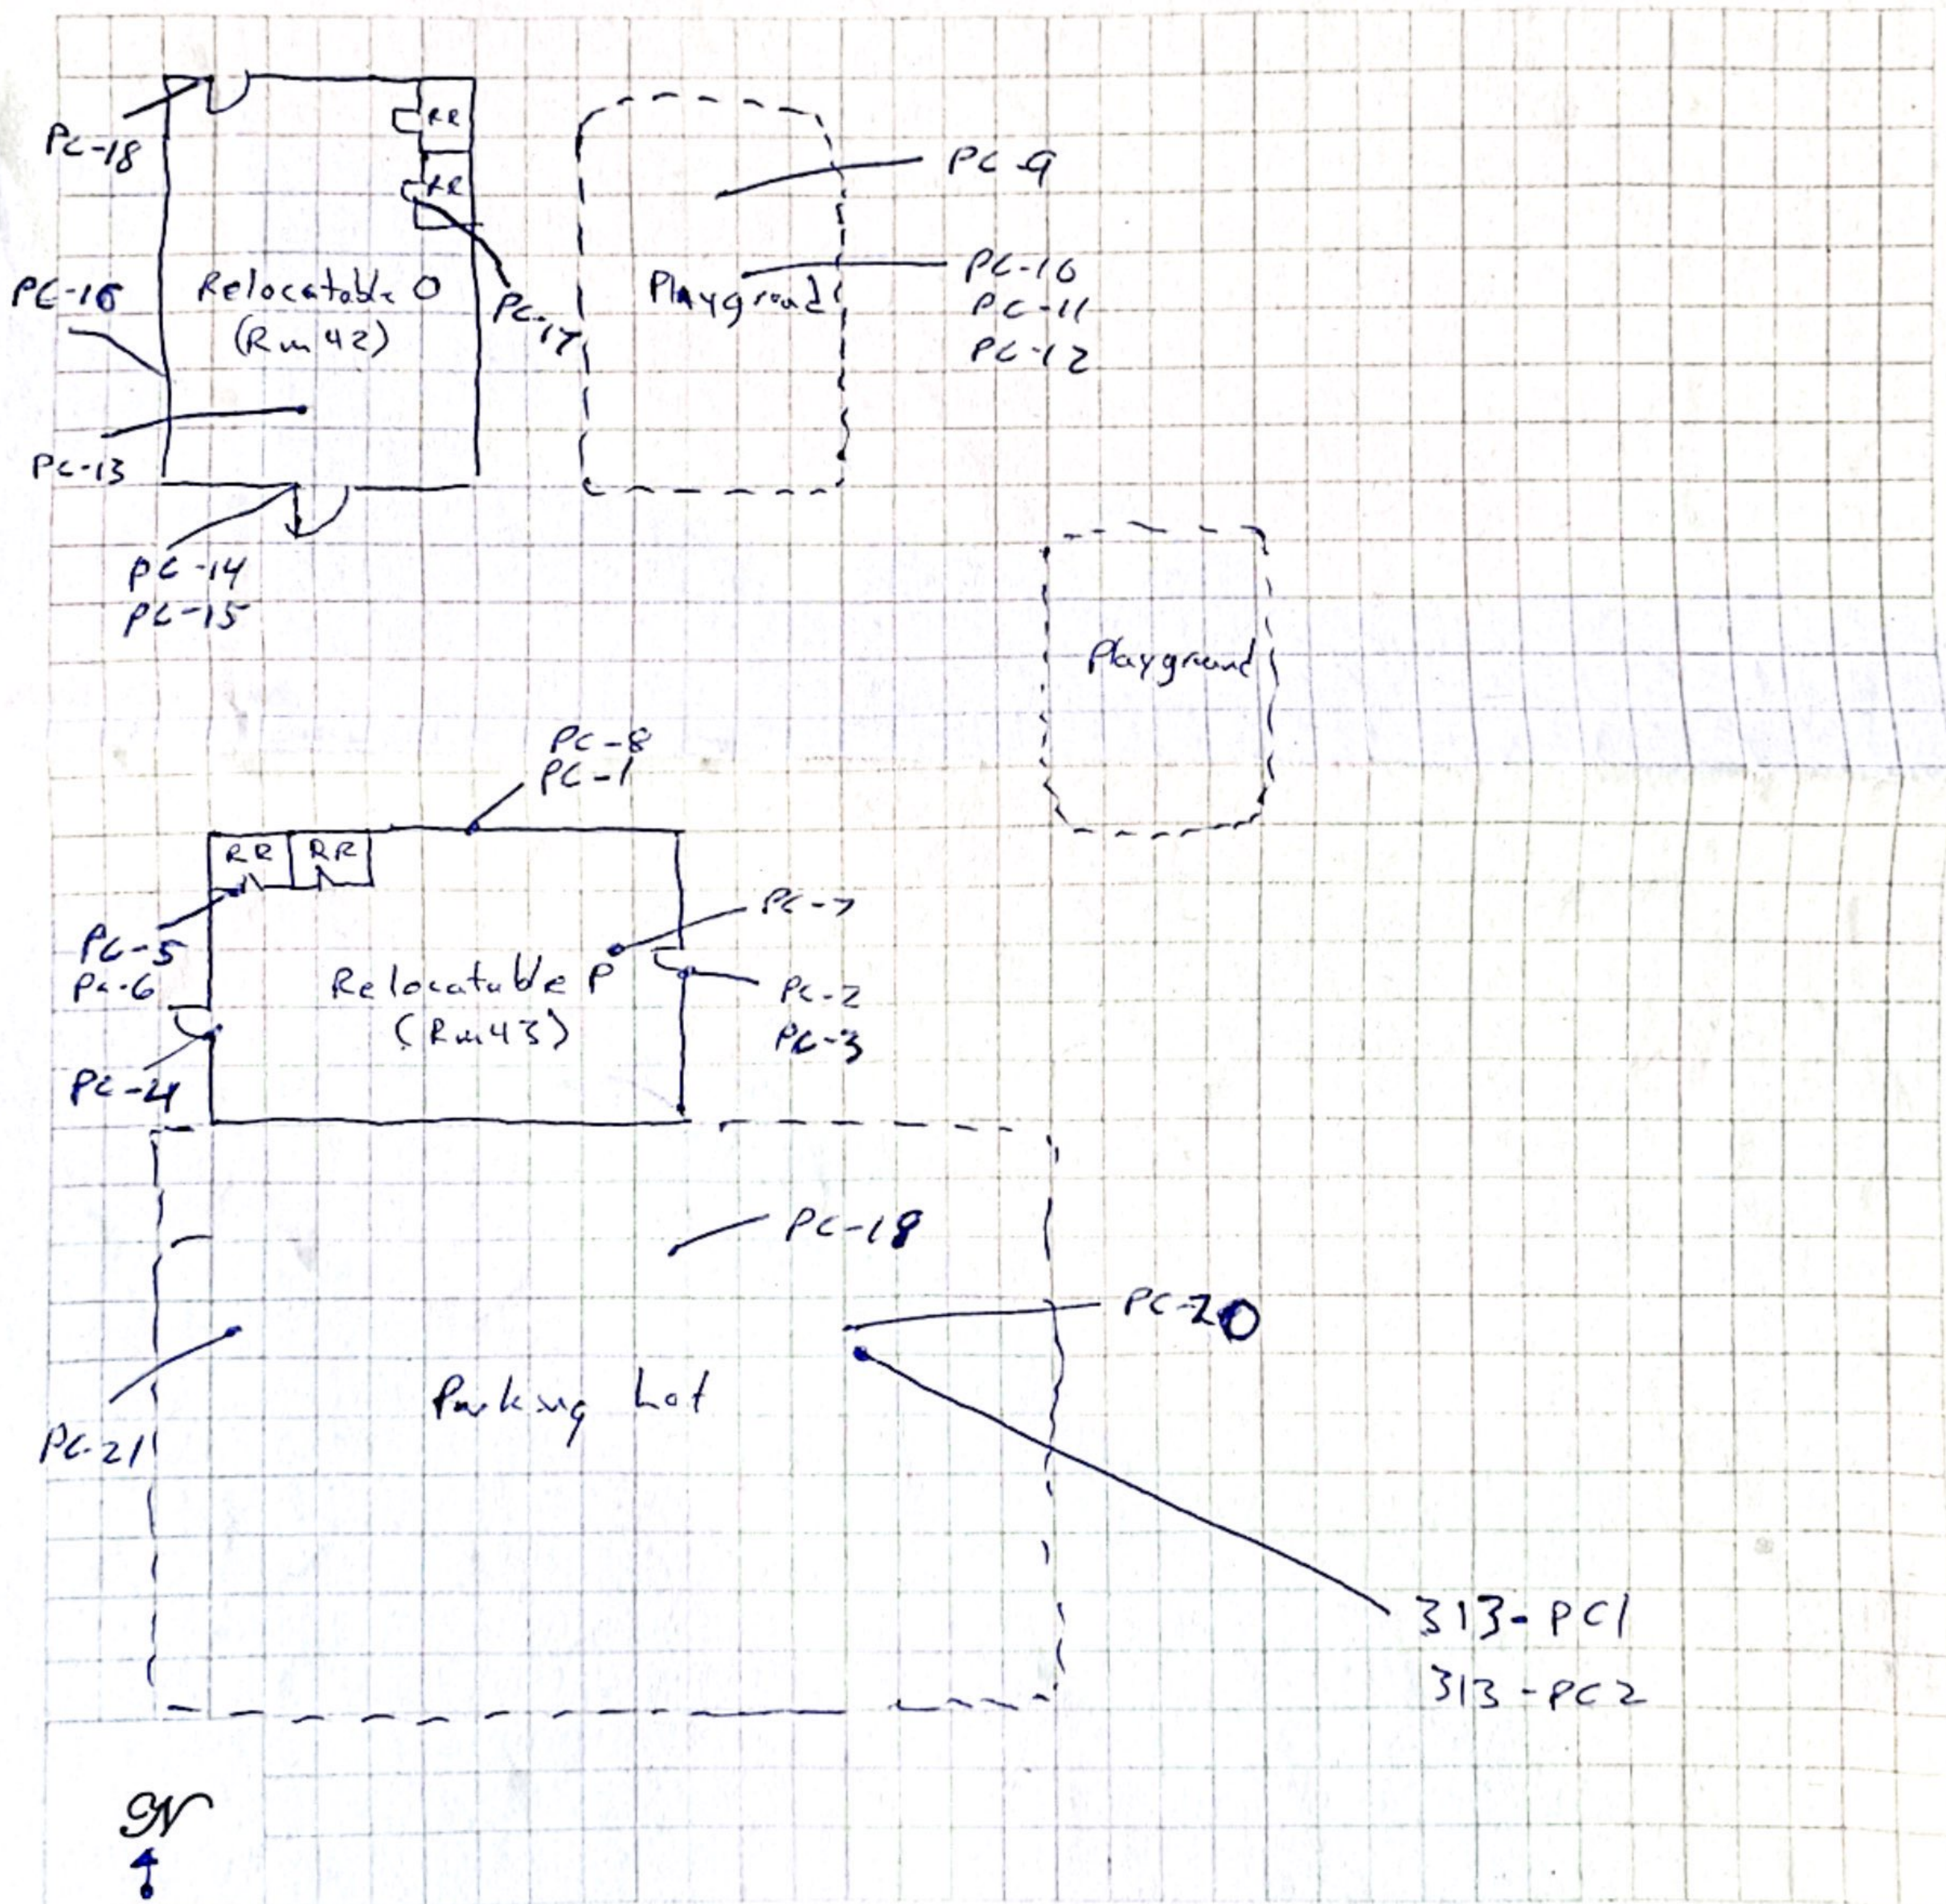
Date:	3-4-2024	CES Representative(s):	Fabian Ruvalcaba
Project No.:		Project Name:	Janson E.S.
Project Location:	Rosemead, Ca	Project Area:	Relocatables PCRM43), O(RM42) Playground, Parking Lot
