LIMITED LEAD-BASED PAINT/CERAMIC TILE INSPECTION REPORT

JANSON ELEMENTARY SCHOOL
PAINTING PROJECT
8628 MARSHALL AVENUE
ROSEMEAD, CALIFORNIA 91770

Project Number EE 20-Z0046-0134
January 22, 2021

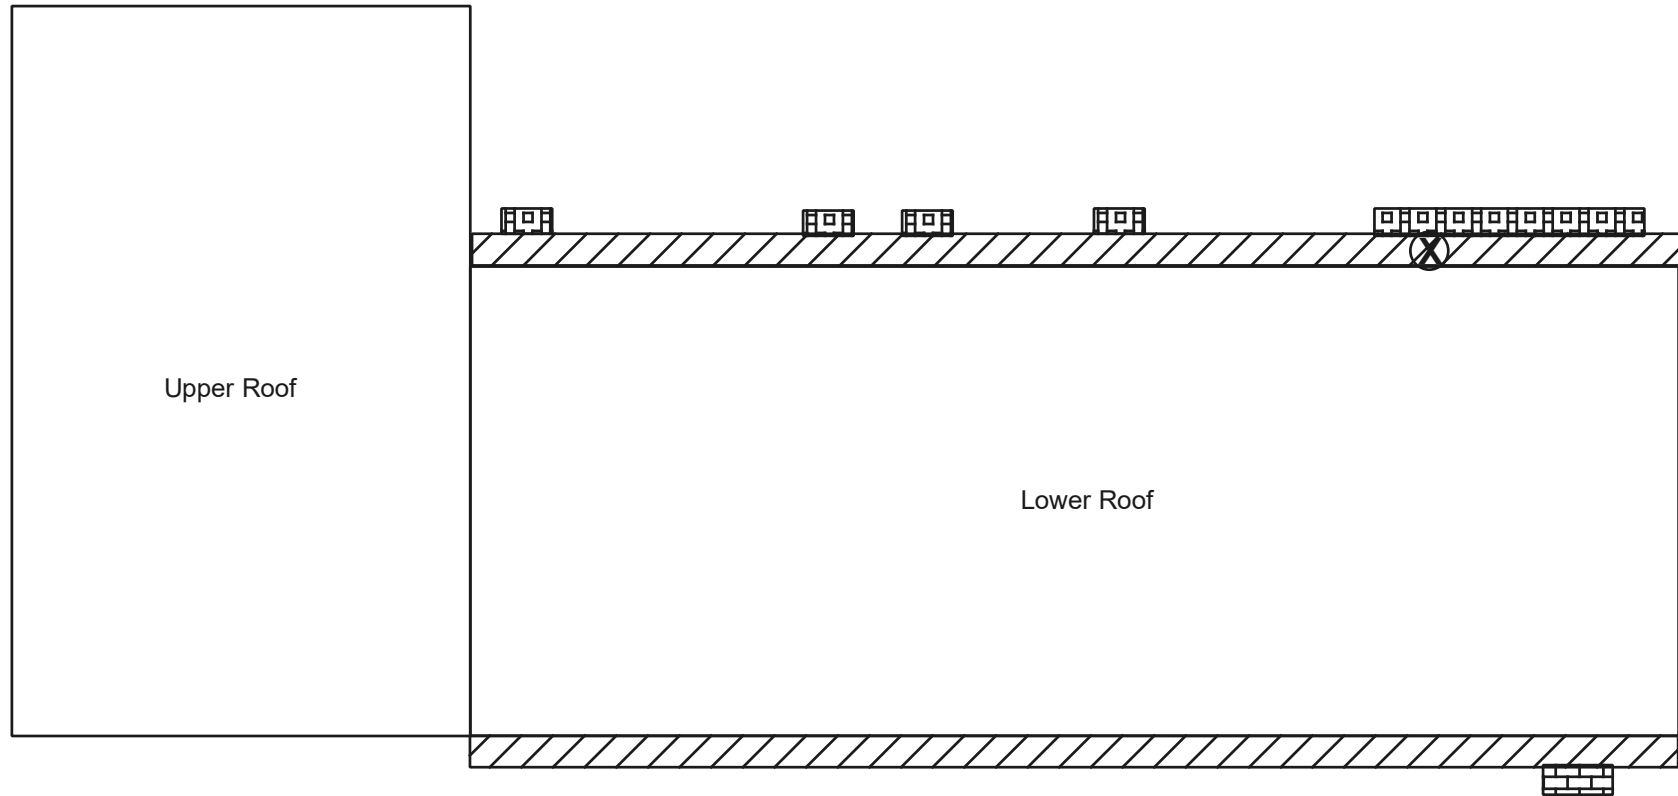
Administration Building/Room 3 Exterior

-   - Wood Eave Components (Eave, Joints, Spacers)
-   - Wood Wall Panel Frame
-   - Wood Window Trim/Casing
-   - Wood Transom Frame
-   - Wood Door Frame

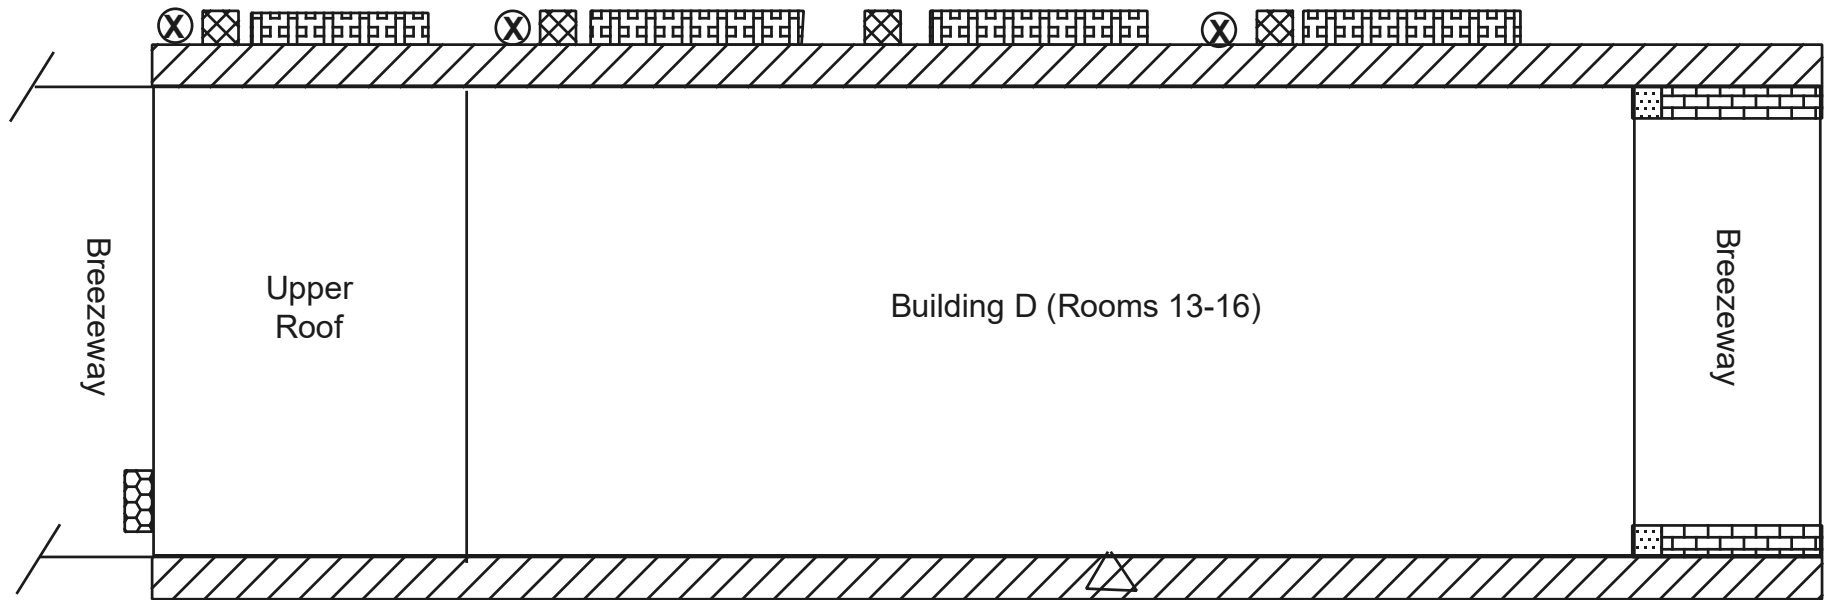
Building D (Rooms 13 through 16) Exterior

- Wood Eave Components (Eave, Joist & Spacers)
- Wood Window Casing
- Wood Wall Trim
- Wood Ceiling Beam
- Metal Ceiling Beam Bracket
- Metal Wall Panel
- Wood Door Frame
- Wood Fire Hose Cabinet Door
- Wood Transom Frame

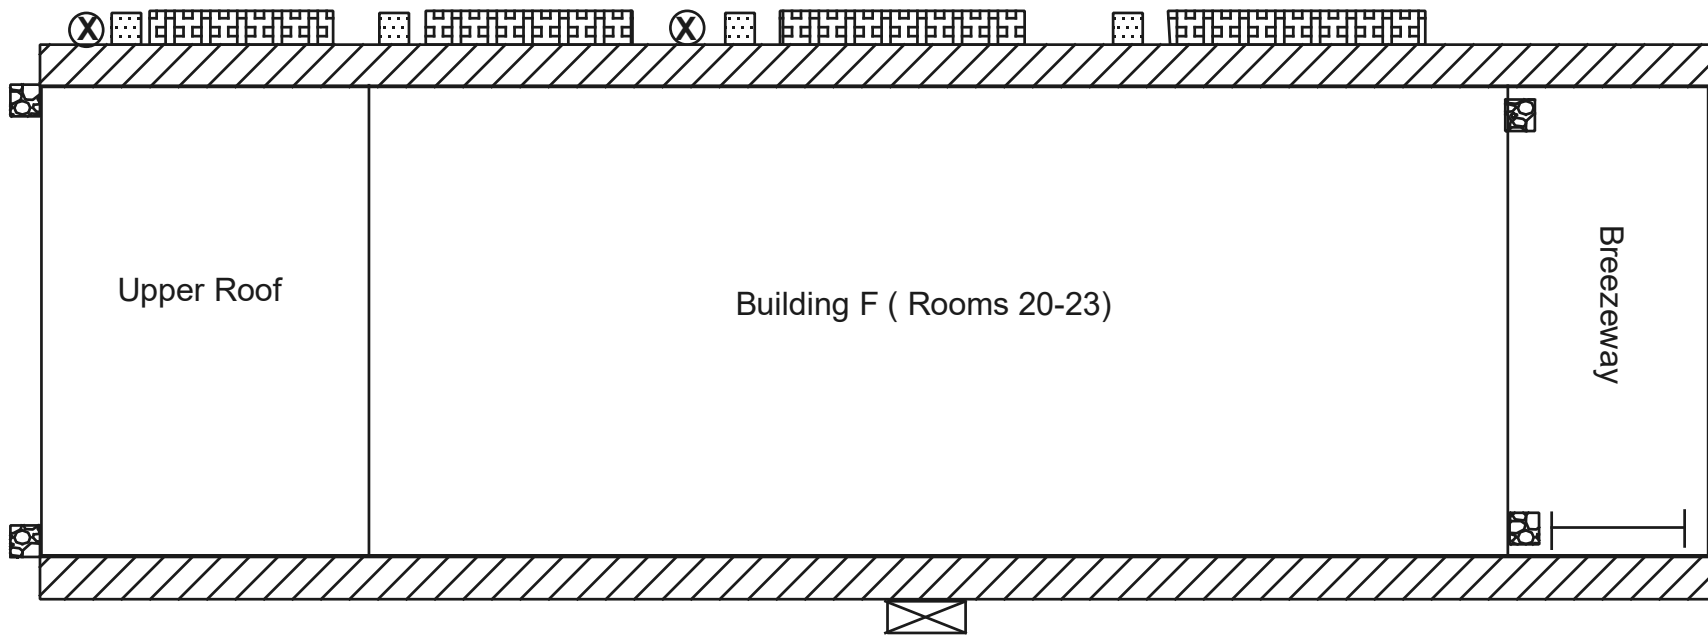
Building F (Rooms 20 through 23) Exterior

- Wood Eave Components (Eave, Joist, Spacers)
- Wood Window Casing
- Wood Wall Trim
- Metal Ceiling Beam Bracket
- Fire Hose Cabinet Wood Door/Metal Door Frame
- Wood Door Frames
- Wood Transom Frames
- Wood Ceiling Beam
