LIMITED LEAD-BASED PAINT/CERAMIC TILE INSPECTION REPORT

SAVANNAH ELEMENTARY SCHOOL
PAINTING PROJECT
3720 RIO HONDO AVENUE
ROSEMEAD, CALIFORNIA 91770

Project Number EE 20-Z0046-0135
February 9, 2021

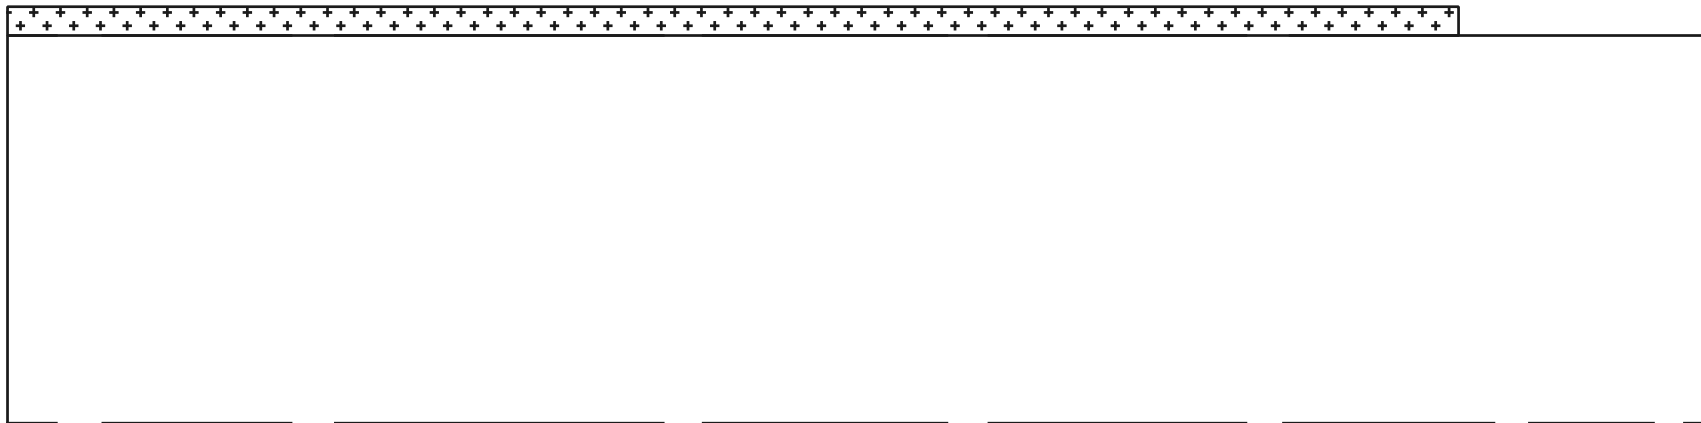
Building C
(Classroom 10 thru 14)
Exterior

- Window Casing (Wood)
