LIMITED LEAD-BASED PAINT/CERAMIC TILE INSPECTION REPORT

SHUEY ELEMENTARY SCHOOL
PAINTING PROJECT
8472 EAST WELLS STREET
ROSEMEAD, CALIFORNIA 91770

Project Number EE 21-Z0046-0066
July 23, 2021

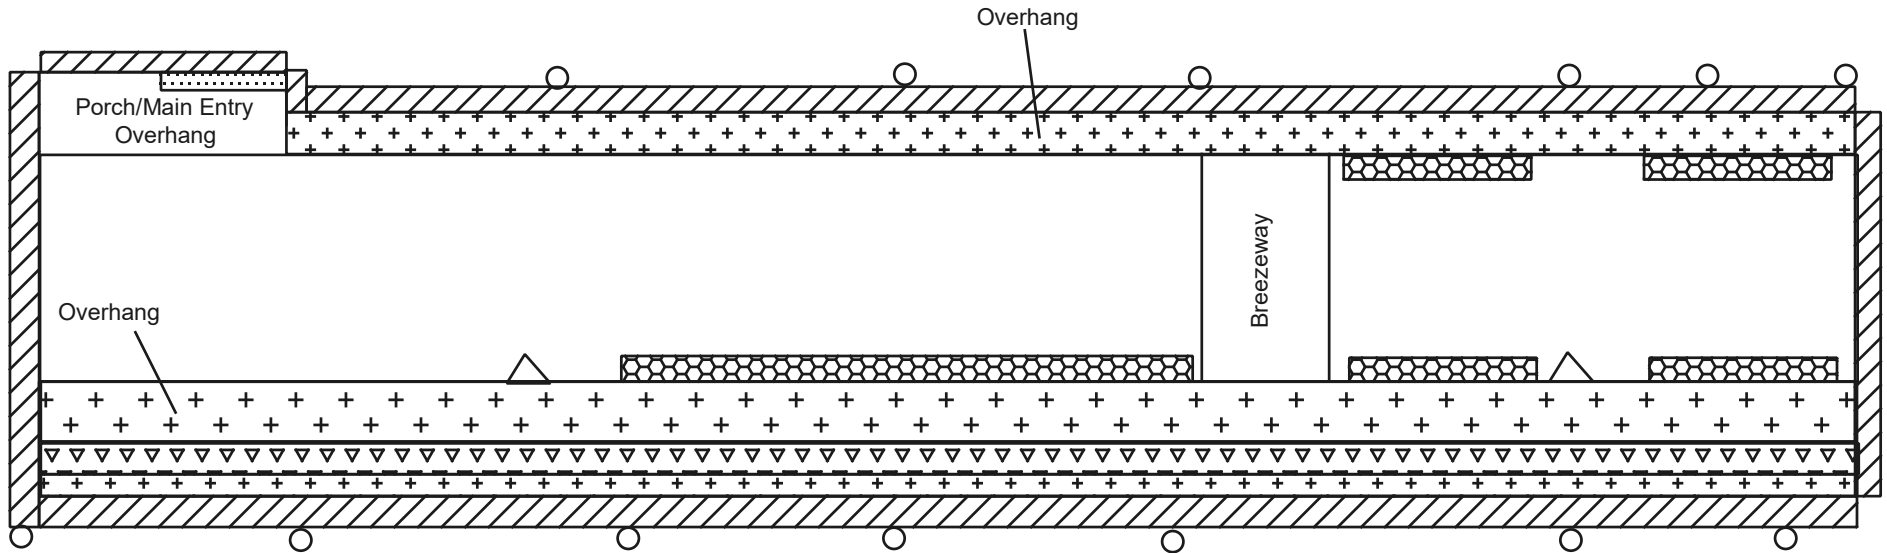
Administration/Classroom Building
(Rooms 1-4)

- Wood Fascia

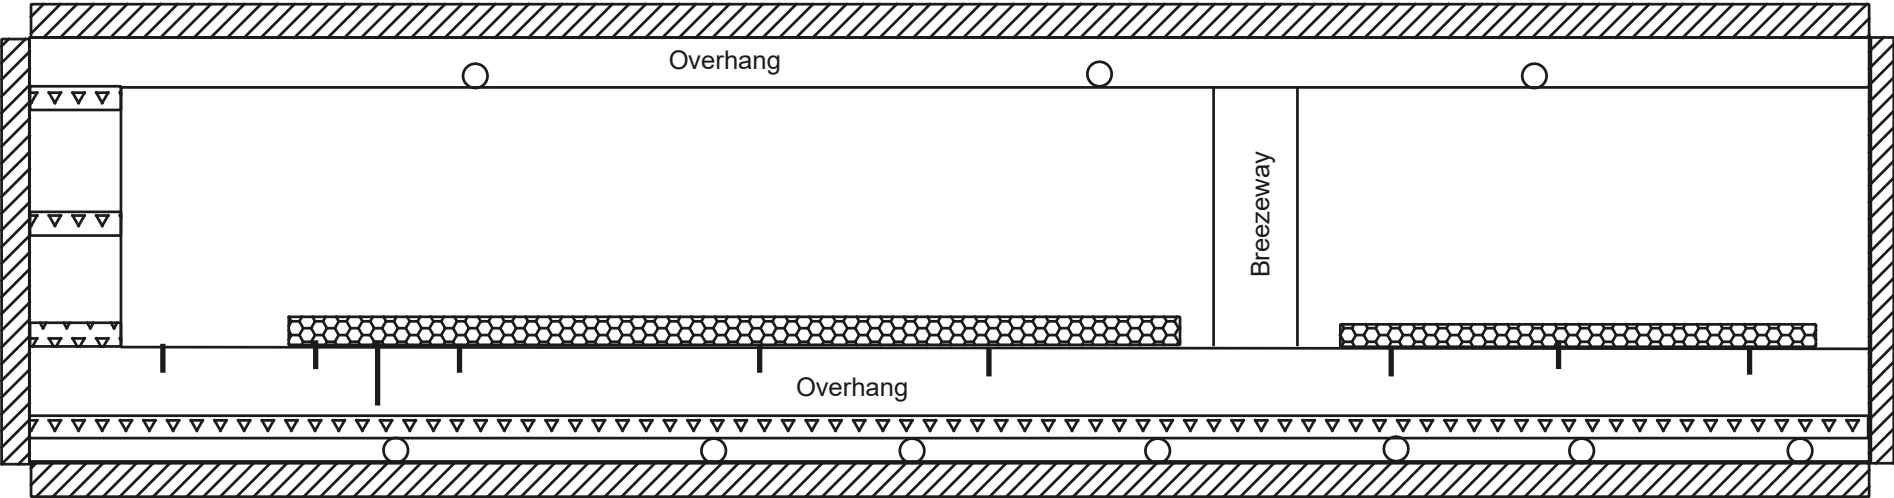
Classroom Building (Rooms 6-12)

- Wood Window Sash
- Wood Fascia
- Wood 9" x 6" Overhang Support Beam
- Metal Conduit
- Metal Downspout

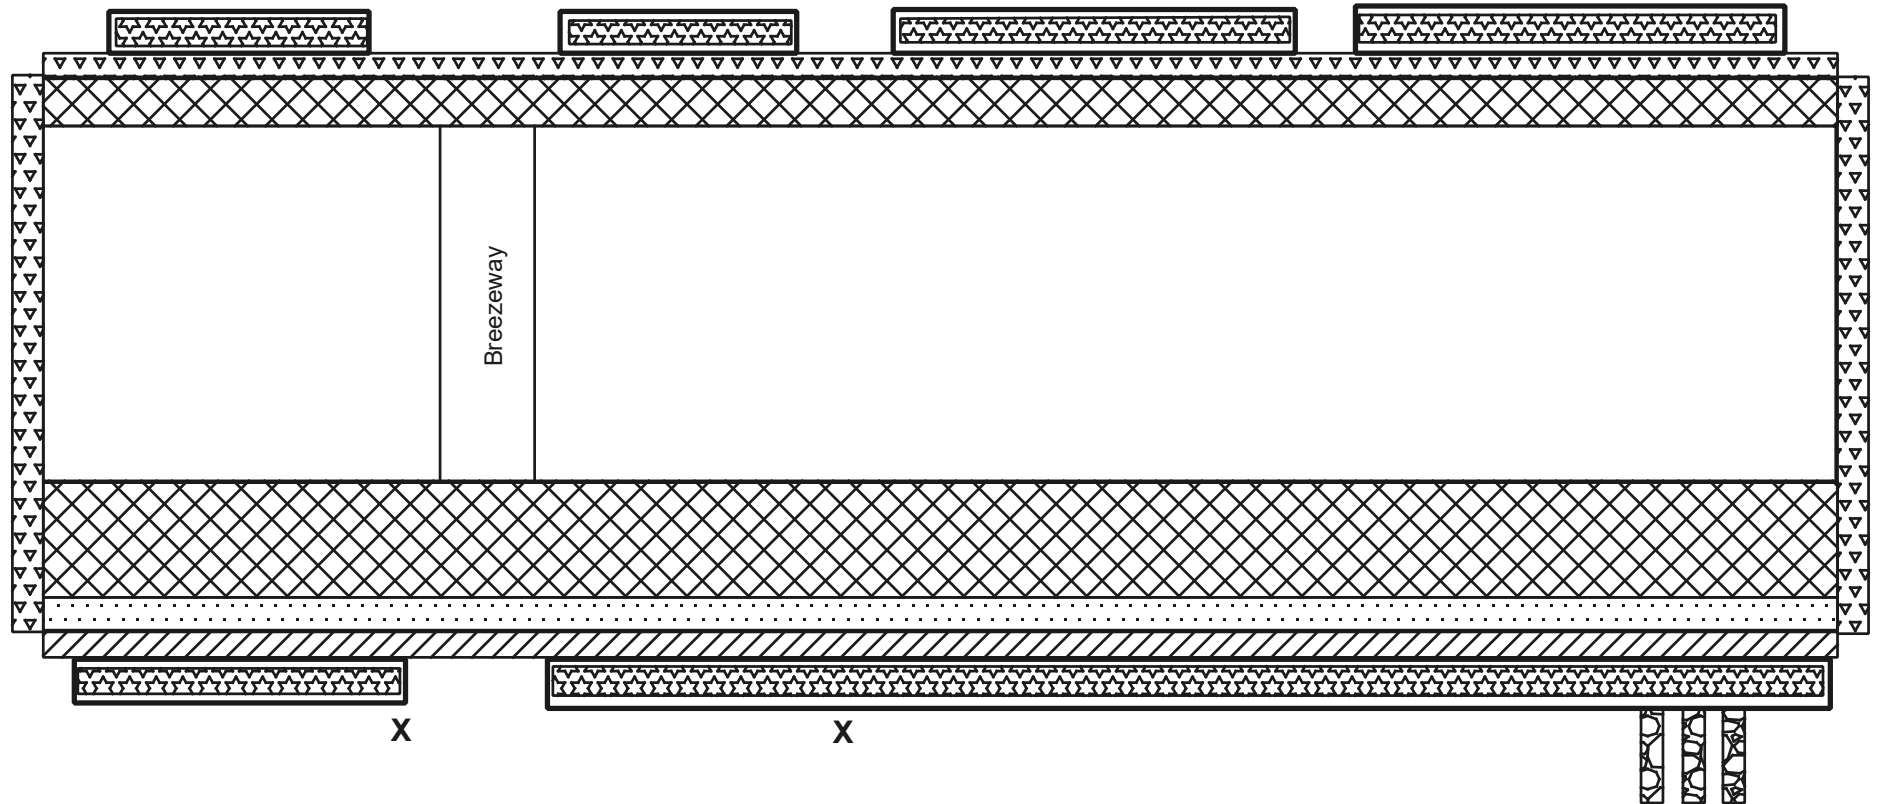
Classroom Building (Rooms 13-16)

- Floor Stripe on Concrete

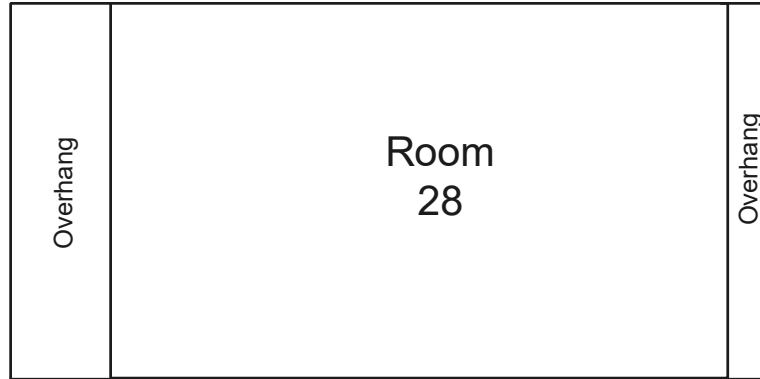
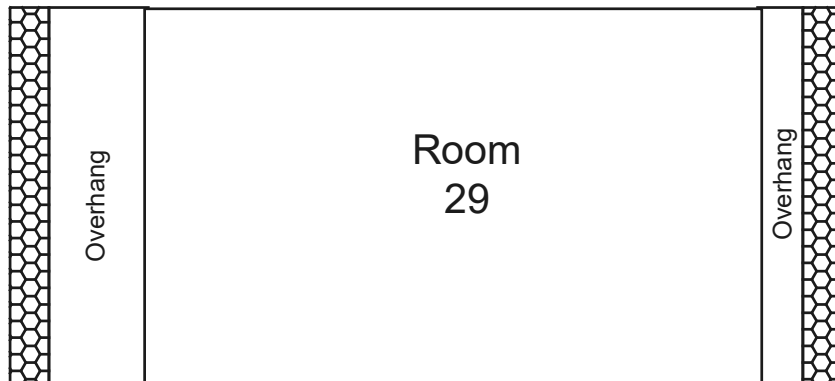
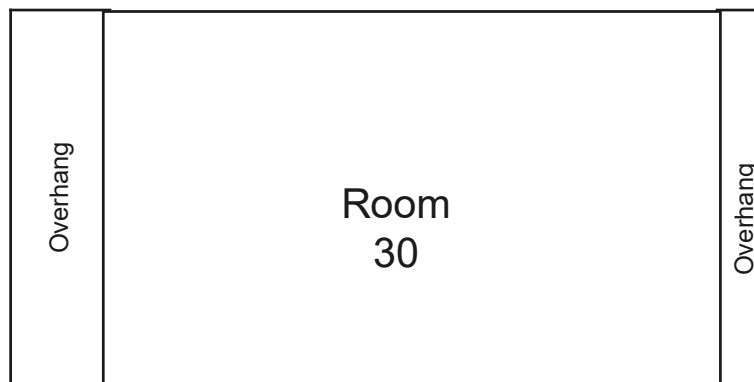
Portables (Rooms 28-30)

- Gutter (Metal)
