LIMITED LEAD-BASED PAINT/CERAMIC TILE INSPECTION REPORT

MUSCATEL MIDDLE SCHOOL
NEW SHADE STRUCTURE AND BUILDING E URINAL & DRINKING
FOUNTAIN
4201 IVAR AVENUE
ROSEMEAD, CALIFORNIA 91770

Project Number EE 23-Z0046-0030
March 13, 2023

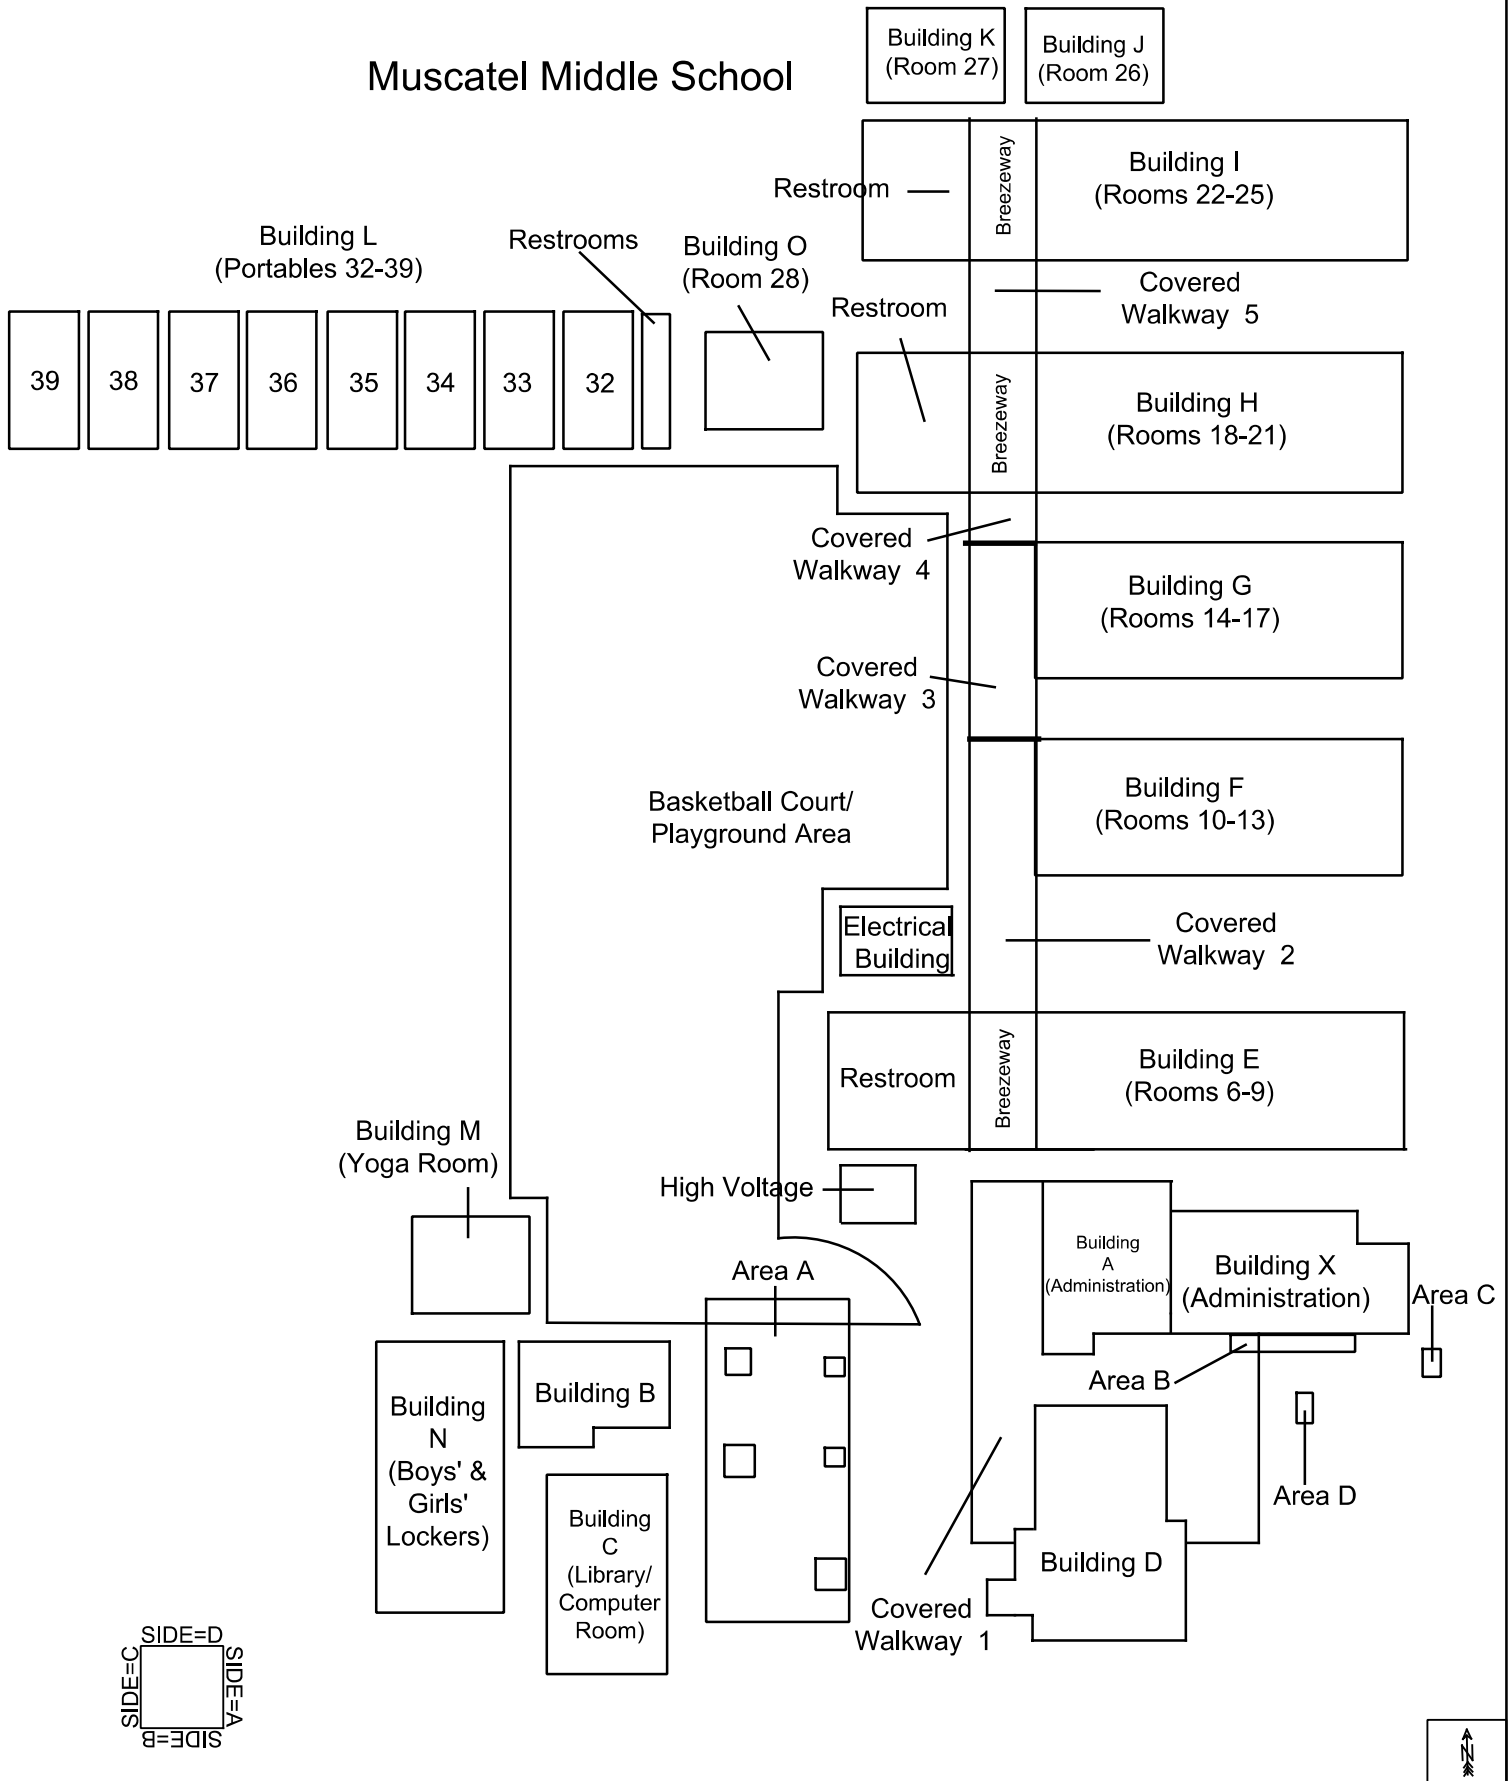
Muscatel Middle School

Info: No Lead-Based Paint Identified
